PROPERTY INSPECTION REPORT

Prepared For: Xxxxx and Xxxxx XXXXXXXXXXXX
Concerning: XXXX Fairgate Dr. Houston, Texas 77094
Inspection Date: 06/15/2019

By: Inspector Name: Chris Oelfke License Number: 8021 Date: 06/16/2019
Signature:
Phone: 713-498-9896 E-Mail: coelfke@earthlink.net

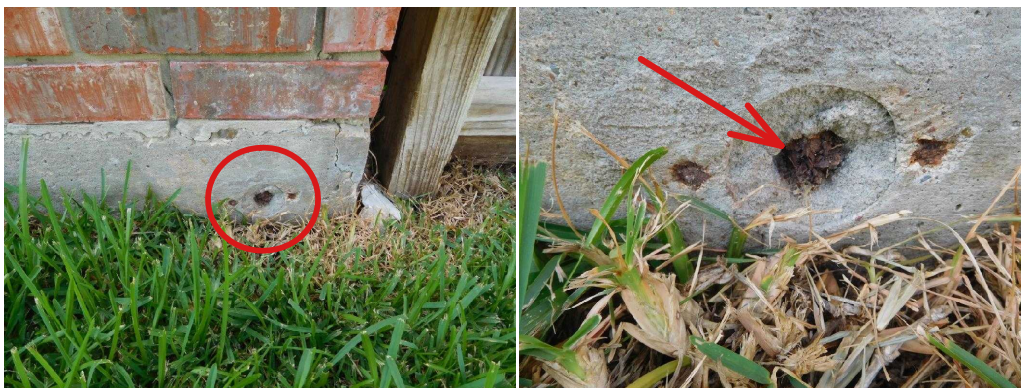
However, some exposed post-tension cable ends were observed at various locations throughout the perimeter of the foundation (see photos). Properly remove any rust or corrosion on the metal cable ends and properly seal or patch over them so that they are not exposed.

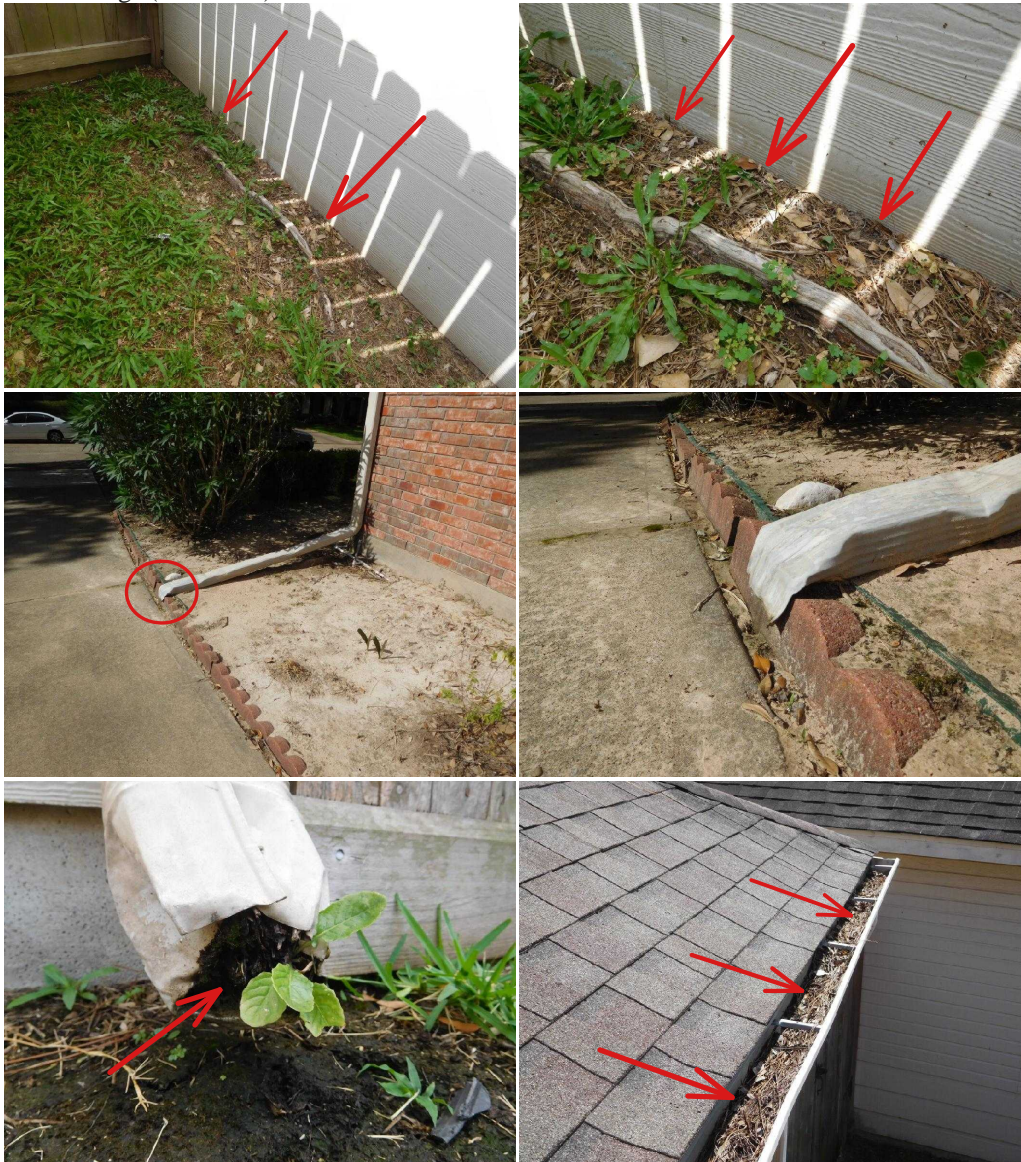
B. Grading and Drainage (continued)

However, high soil/low footing was noted at the perimeter of the foundation at the garage (see photos). A 5 to 7 inch clearance between the soil and the top of the slab is adequate. Clearances less than this range create conditions considered conducive to termite infestation and moisture penetration.

A few of the gutter downspouts are crushed and partially closed (See photos). Repair/replace downspout kickouts where needed so that they drain properly.

It was noted that some sections of the gutters are clogged with pine needles, leaves, and debris (see photo). Periodically clean out the gutters.

I recommend installing gutter downspout extensions to direct runoff water away from the perimeter of the foundation.

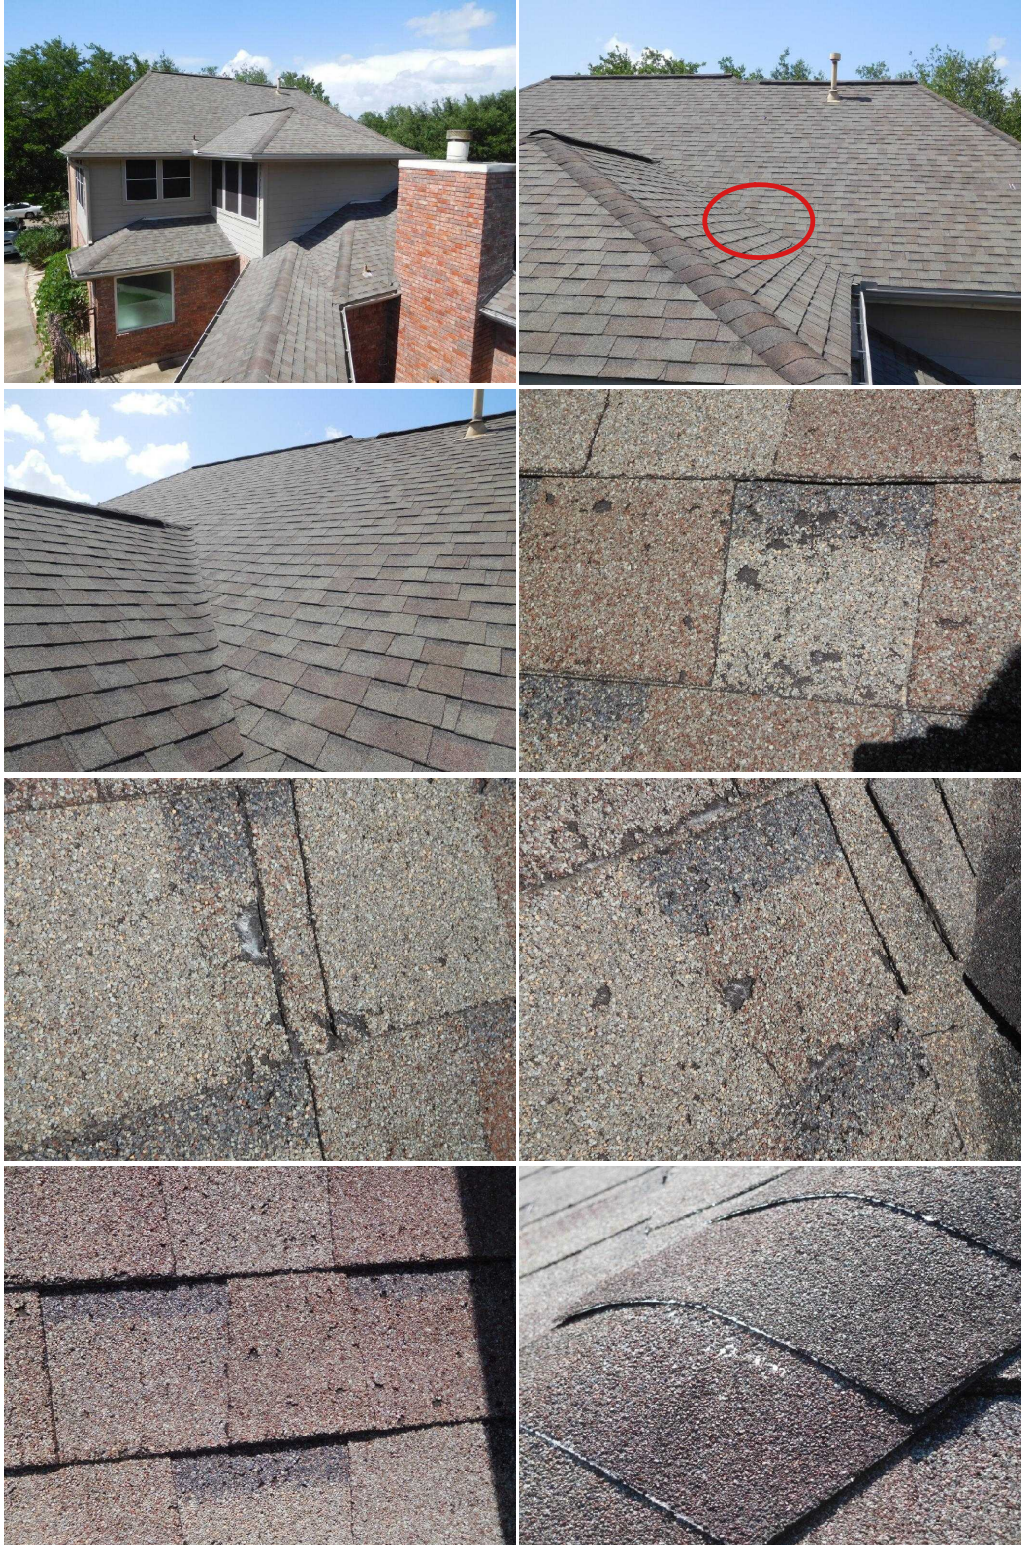
Wear due to age (such as partial aggregate granule separation from individual shingles) was noted throughout the surface of the roof covering (see photos).

It appears that an active leak may be preset at one of the valleys at the rear plane of the roof. This was noted by elevated moisture content at the interior drywall in the southeast corner of the upstairs bonus room and the jack rafter in the attic space above (see photos). Repair as needed.

Small gaps were noted at the tops of the metal flashing on the plumbing vents (see photos). I recommend having the vent flashing properly sealed or replaced as necessary.

A qualified roofing contractor is recommended to evaluate and estimate for repairs or replacement.

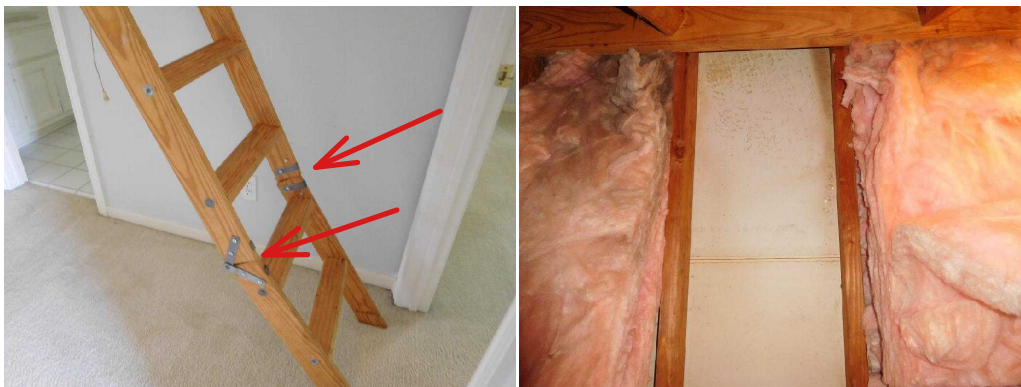
However, a few sections of the vertical wall insulation (adjacent to the upstairs bonus room) are missing or have come loose and have fallen away from the wall in the attic (see photo). Replace. Installing new material and increasing the depth can improve energy efficiency.

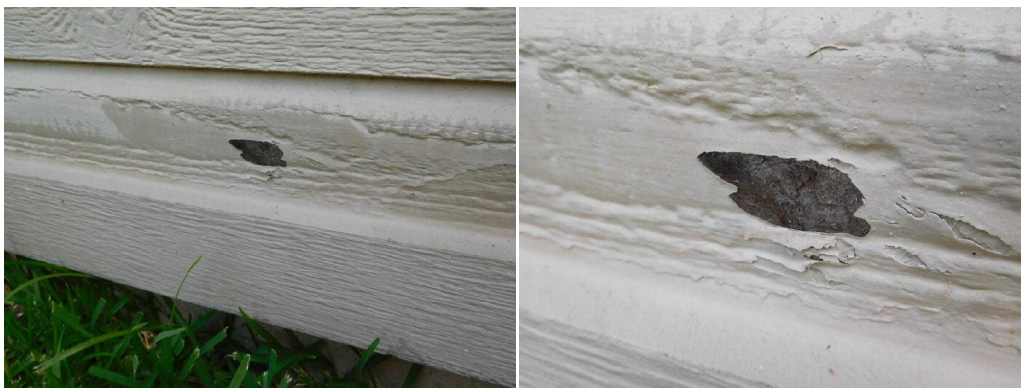
However, deterioration due to moisture penetration was noted at the bottom edges of a few sections of the composition siding at the exterior, such as on the garage (see photos). Repair or replace exterior siding as needed.

Grain splitting and minor deterioration due to moisture penetration were noted at the ends of the wooden fascia board trim at various locations (see photos). Repair or replace exterior trim as needed.

Elevated moisture content was noted in the drywall in the upstairs bonus room (see photos). This appears to be the result of a leak in the attic space above, possibly a roof leak at the valley. Once the leak is located and repaired replace wet and damaged material as needed. Moisture readings were made using a non-destructive moisture meter.

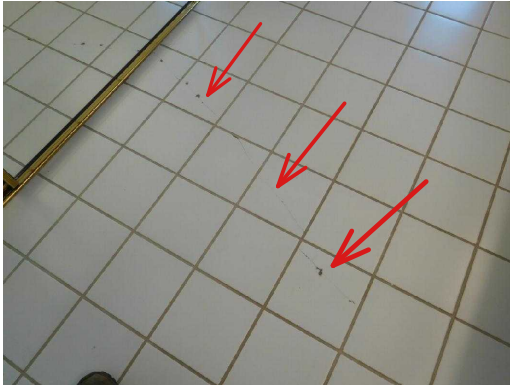
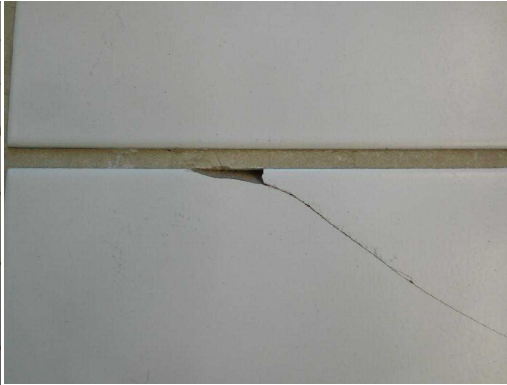
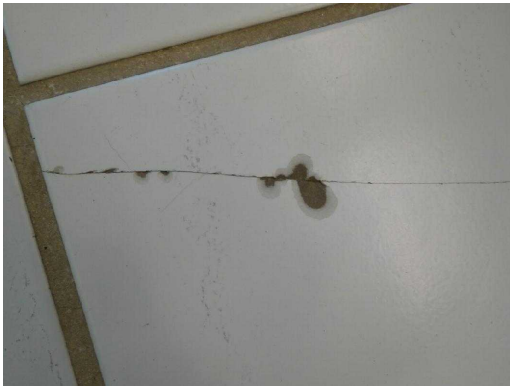
F. Ceilings and Floors (continued)

However, cracked tiles were noted in the floor in the master bathroom (see photos). Replace as needed.

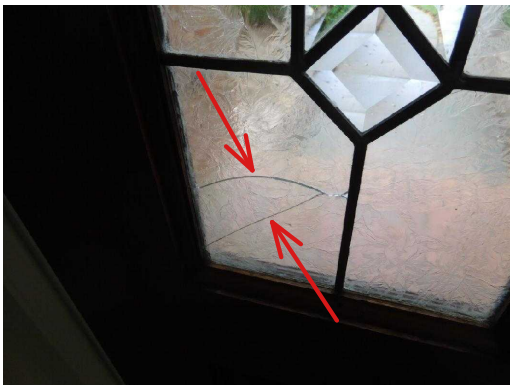
However, a section of cracked glass was noted in the front door glazing (see photo). Re-glaze as needed.

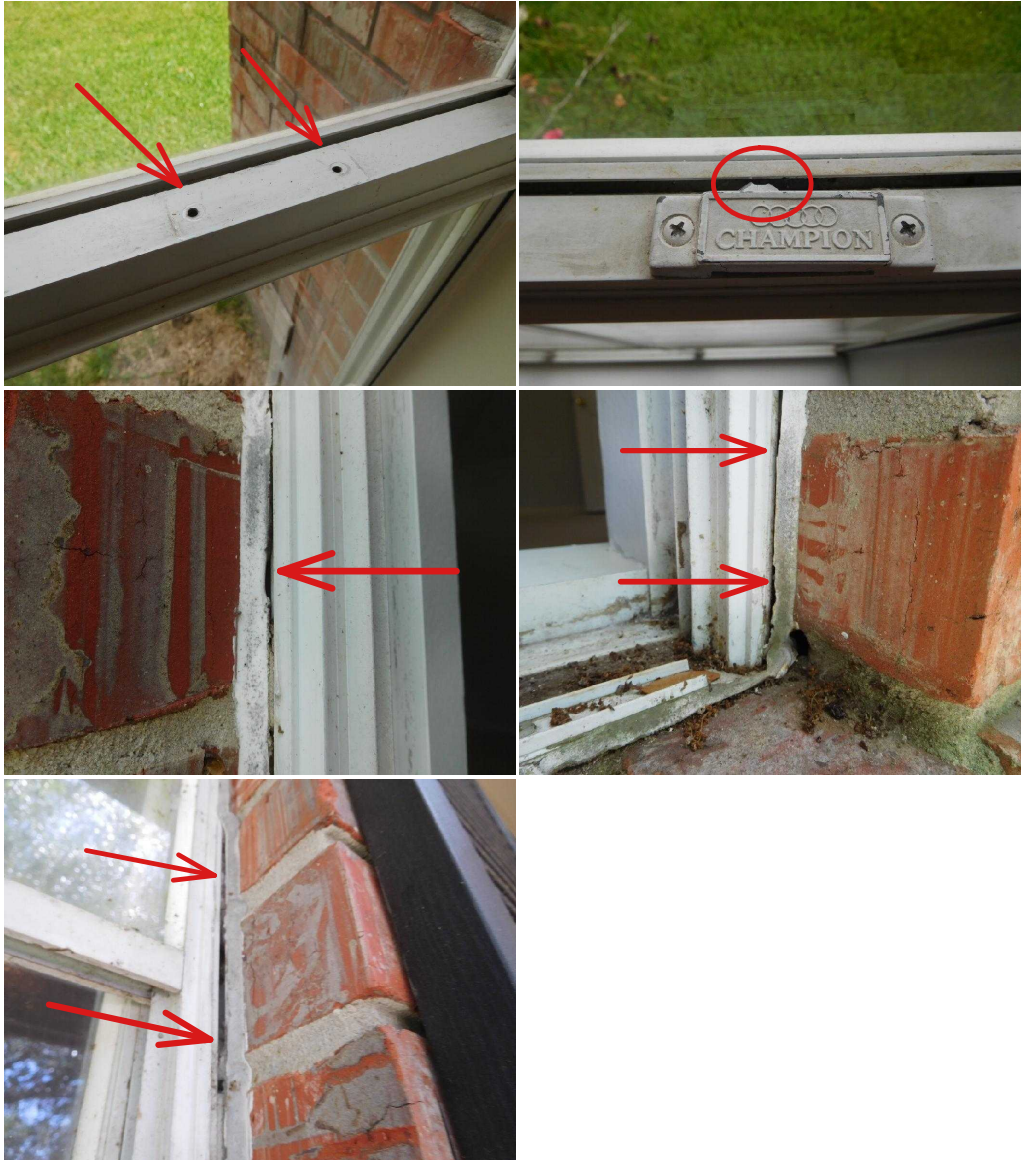
One of the locks is missing at the window in the southeast corner of the dining room (see photo). Replace.

One of the locks is broken at the window in the northeast corner of the living room (see photo). Replace.

I recommend properly sealing any small gaps at the perimeter edges of the windows at the exterior side (see photos).

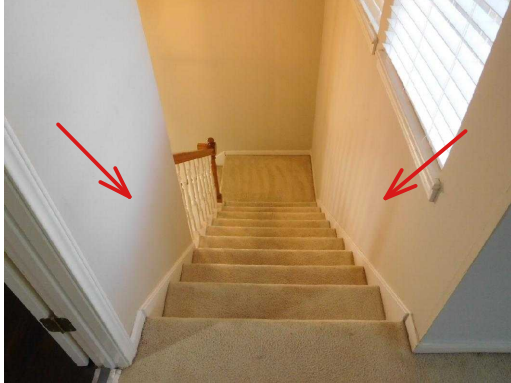
However, there is no handrailing installed at the top portion of the staircase (see photo). Install handrailing as per code and safety.

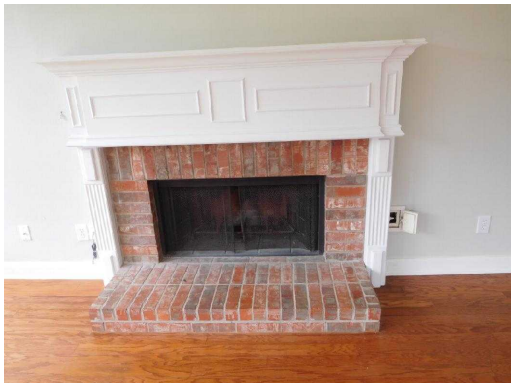
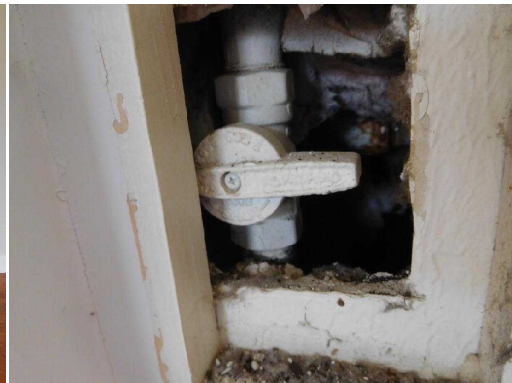
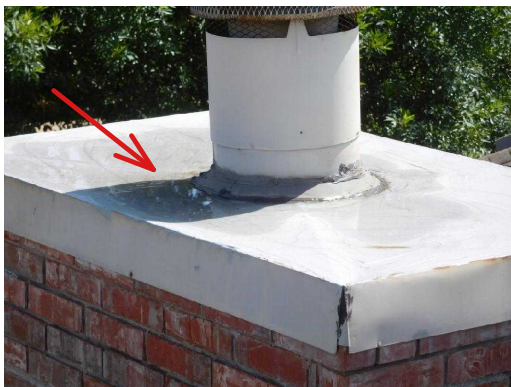
I recommend installing a new valve that requires a valve key to operate the gas supply line as a safety precaution (see photo).

Standing water was noted on top of the chimney crown (see photo). Adjust as needed so the crown properly sheds water.

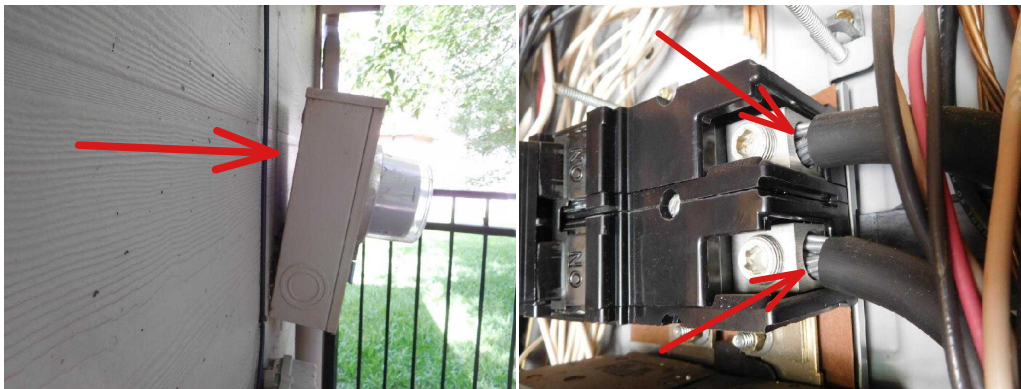
It is recommended that an anti-oxidant gel be applied to the aluminum service lines where they are secured to the contact lugs (see photo). This will prevent corrosion from occurring at these connections.

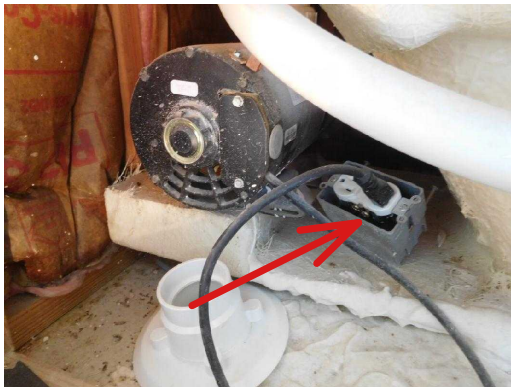
However, it was noted that the tub's electric pump outlet is resting on the sub-floor under the tub (see photo). I recommend securely mounting this outlet on one of the framing cripples of the tub surround so that it is up off of the floor. Replace the missing faceplate on the outlet.

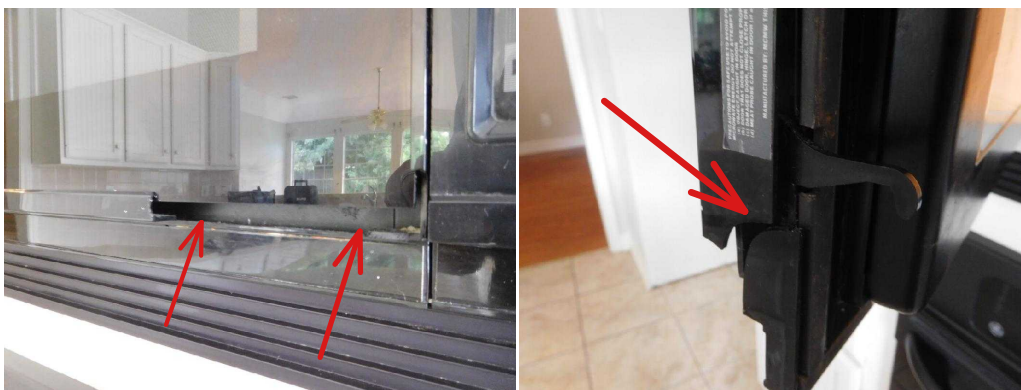
However, the door is cracked/broken (see photos). Service as needed or replace the microwave.

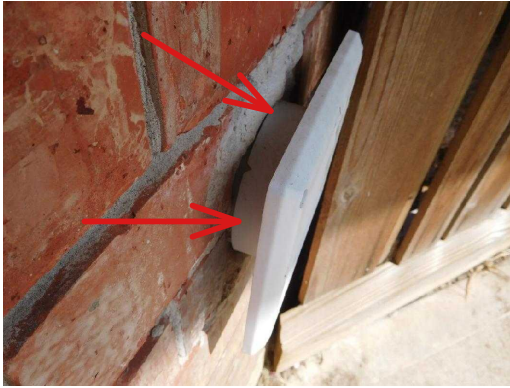
However, I recommend setting the exterior vent hood flush against the exterior wall and sealing the perimeter edges of the exterior dryer vent hood (see photo).
