PROPERTY INSPECTION REPORT

Prepared For: XXXXXXXX XXXXXX
Concerning: XXXXX Wild Oaks Dr. Houston, Texas 77090
Inspection Date: 07/01/2019
By: Inspector Name: Chris Oelfke License Number: 8021 Date: 07/02/2019
Signature:
Phone: 713-498-9896 E-Mail: coelfke@earthlink.net

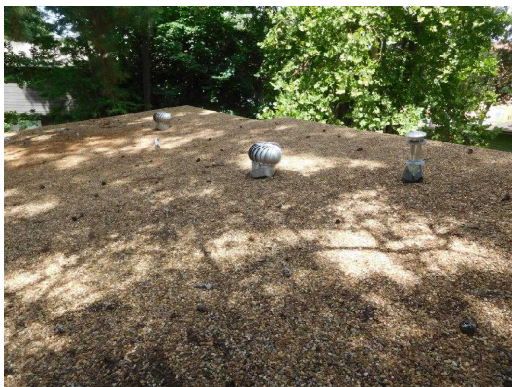
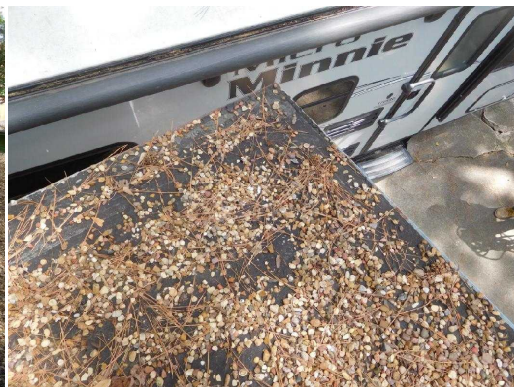
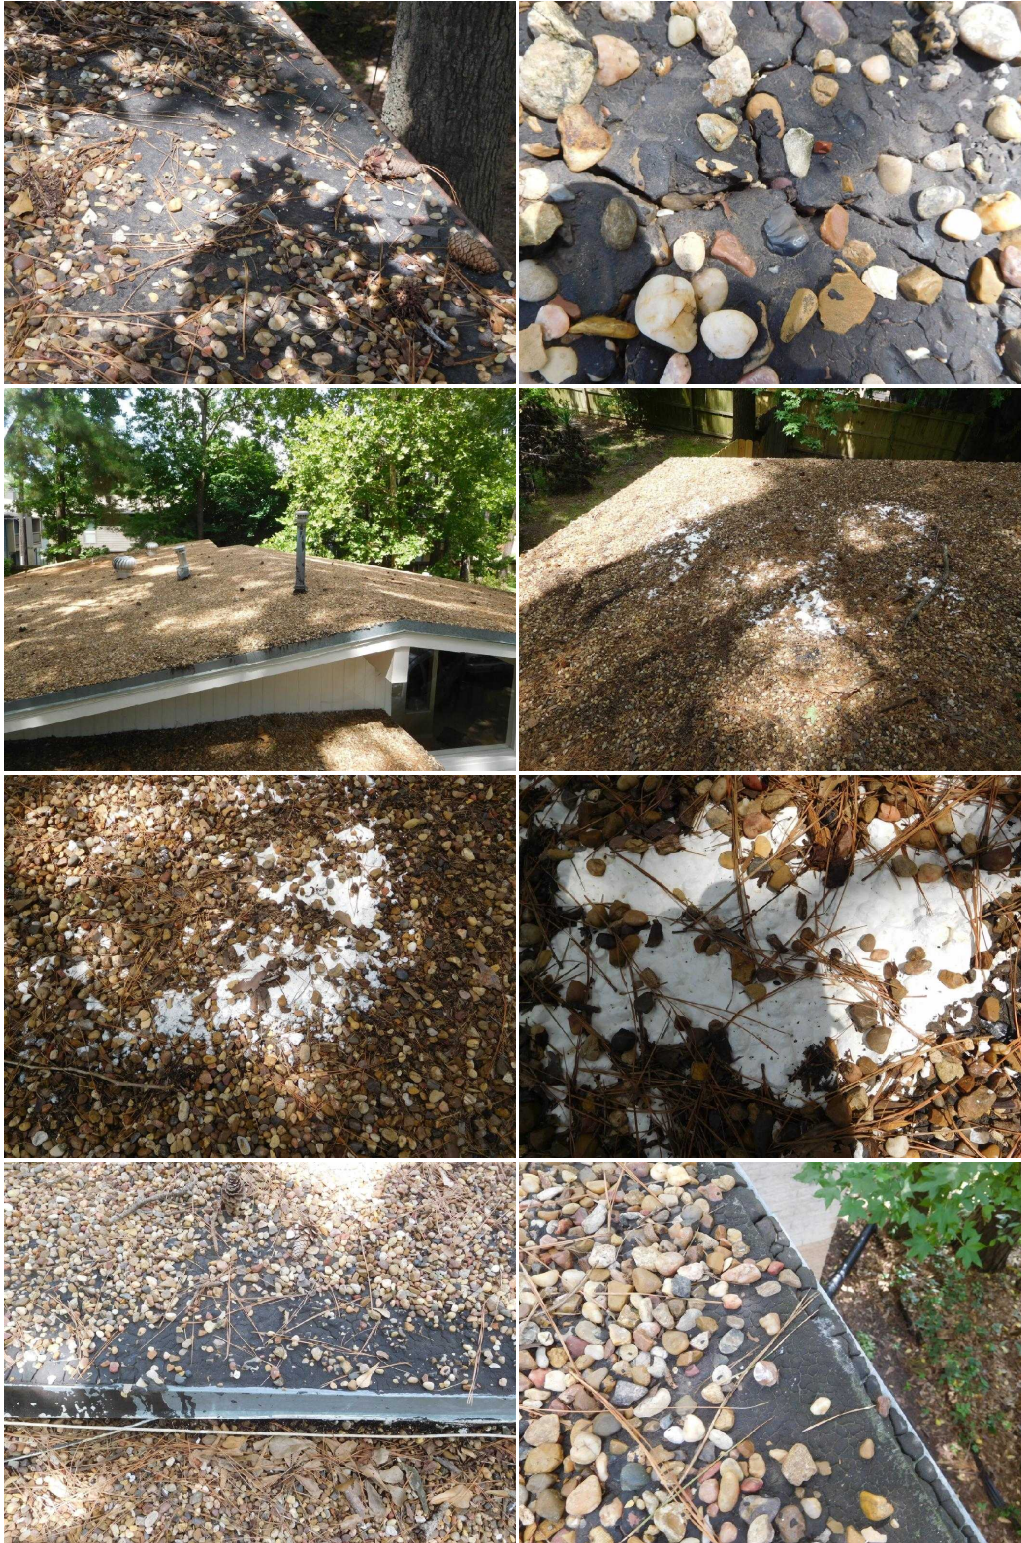
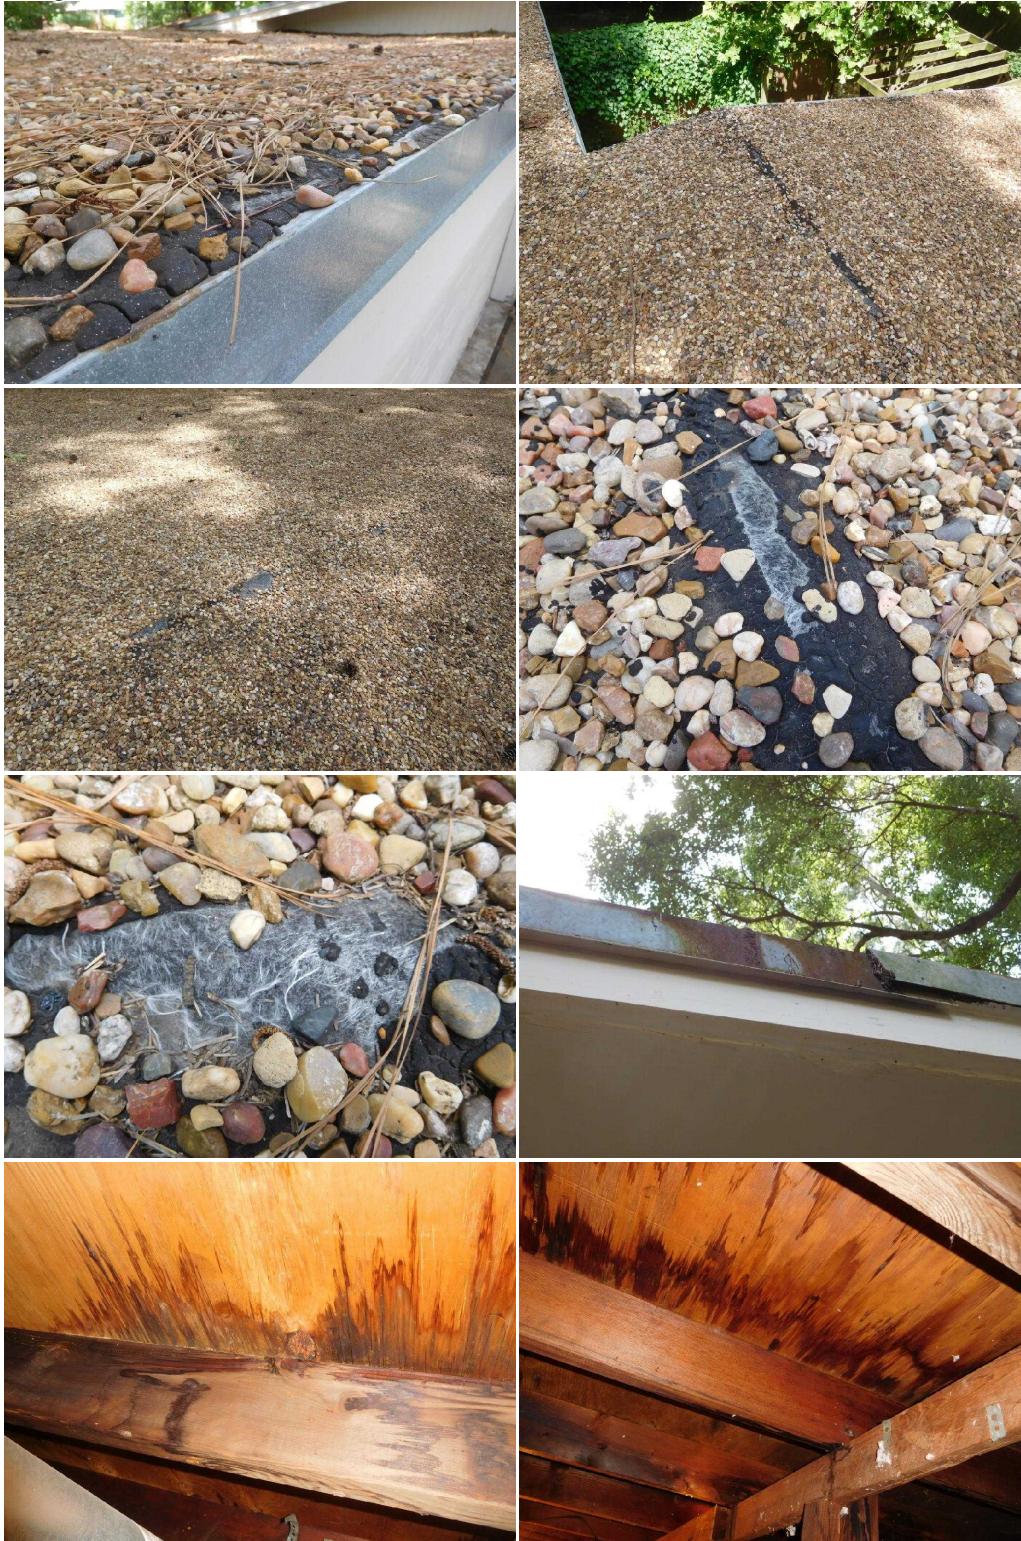
Comments: Built-up Tar and Gravel. Many areas of the roof have asphalt coating that is exposed and is oxidized, shrinking back, and cracked (see photos). Many areas have thinly applied/missing gravel.

Exposed roofing felt and its fiberglass mat was noted along the roof's peaks (see photos).

Some of the drip edge flashing is oxidized and rusting (see photo).

Stains were noted at the underside of the wooden roof sheathing (viewed in the attic space). Stains, patched/repared sections and elevated moisture levels were noted at the garage ceiling (see photos). Moisture readings were made using a non-destructive moisture meter.

I recommend cutting back any overgrown trees, bushes or foliage from the roof surface (see photos).

A qualified roofing contractor is recommended to evaluate the roof and estimate for repairs or replacement.

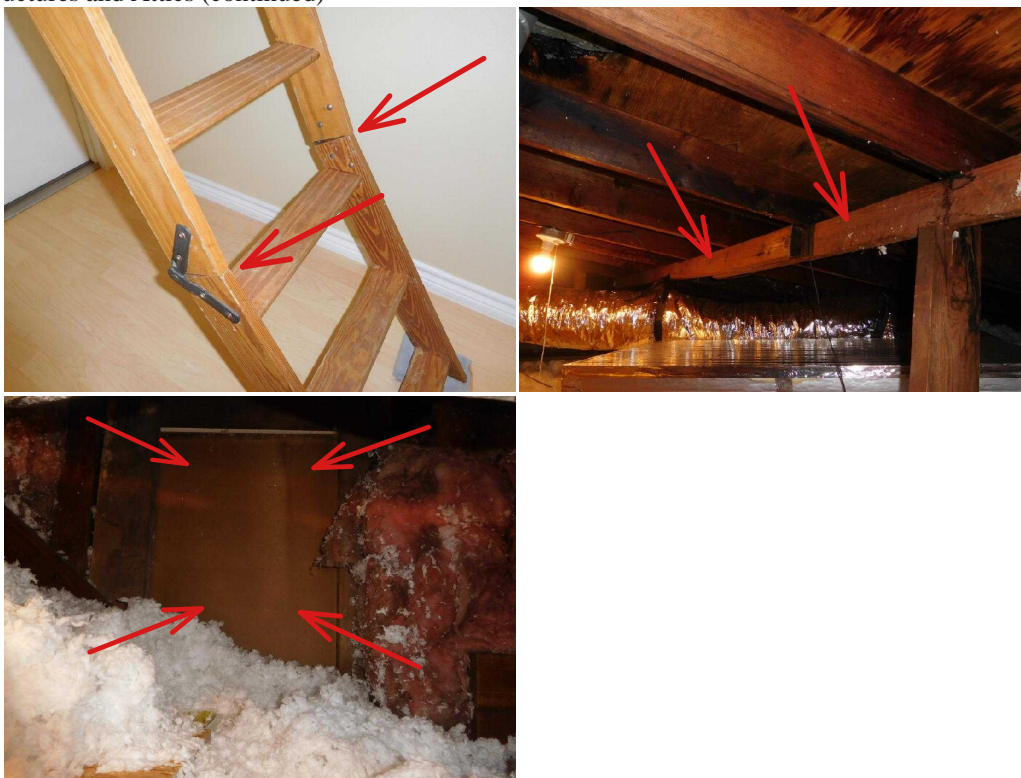
Comments: 2x6 Rafter. It was noted that the lower section of the attic access ladder was cut at the incorrect length and the ladder hyper-extends slightly and is less stable as a result (see photo).

It was noted that the purlins are 2x4 dimension boards (see photo). The current building standard is to have the purlins be the same dimension as the rafters (2x6 in this case). No evidence of excessive sagging or structural deficiency was noted.

A few sections of the vertical wall insulation adjacent to the vaulted ceiling in the entryway and living room have come loose and have fallen away from the wall in the attic (see photo). Replace missing insulation where needed.

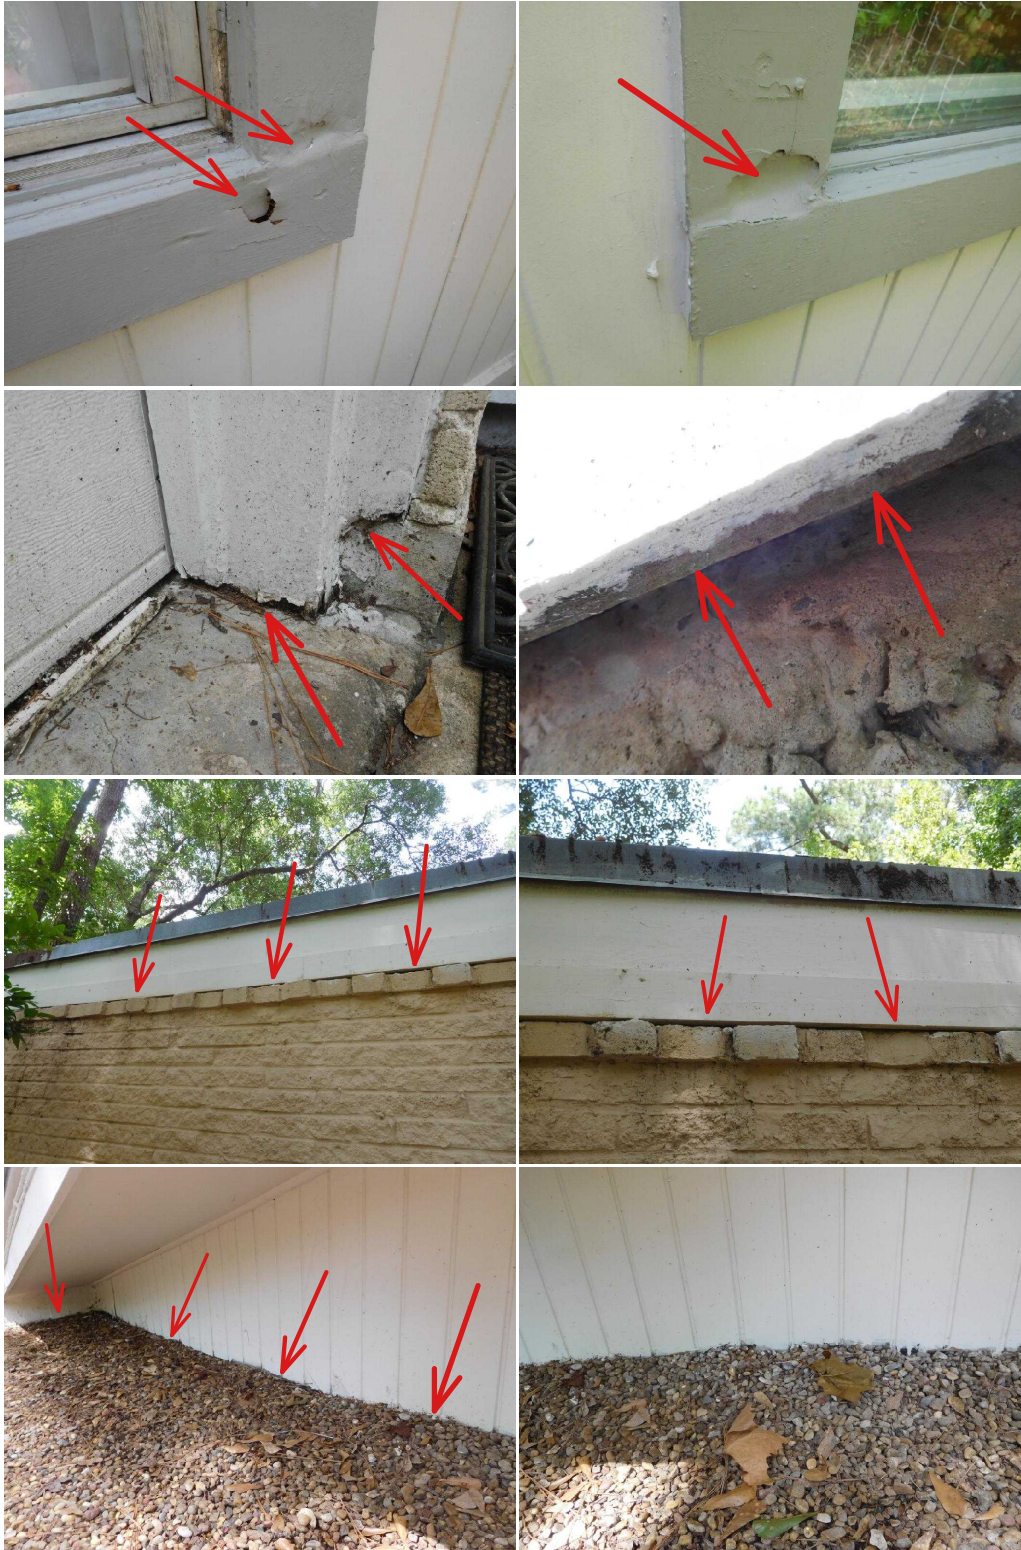
However, deterioration due to moisture penetration was noted at a few sections of the wooden trim throughout the exterior, such as at the window trim at the back of the house and garage door frame (see photos). Repair or replace exterior siding and trim as needed.

It was noted that the exterior siding on the rake walls above the garage has been installed directly in contact with adjacent roof surfaces (see photos). A 1" - 1 1/2" space should be left between the bottom edge of the siding and the roof surface to allow for drying and to keep moisture away from the bottom edges of the siding.

Keep all exterior siding and trim properly sealed and painted to prevent excessive moisture penetration and preserve the condition of the material.

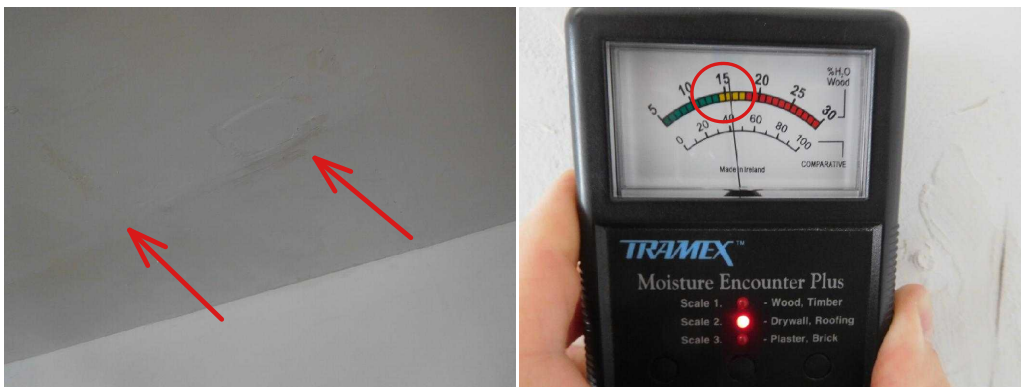
However, stains, patched/repaired sections and elevated moisture levels were noted at the garage ceiling (see photos). Once the roof covering has been serviced or replaced replace wet and damaged materials where needed. Moisture readings were made using a non-destructive moisture meter.

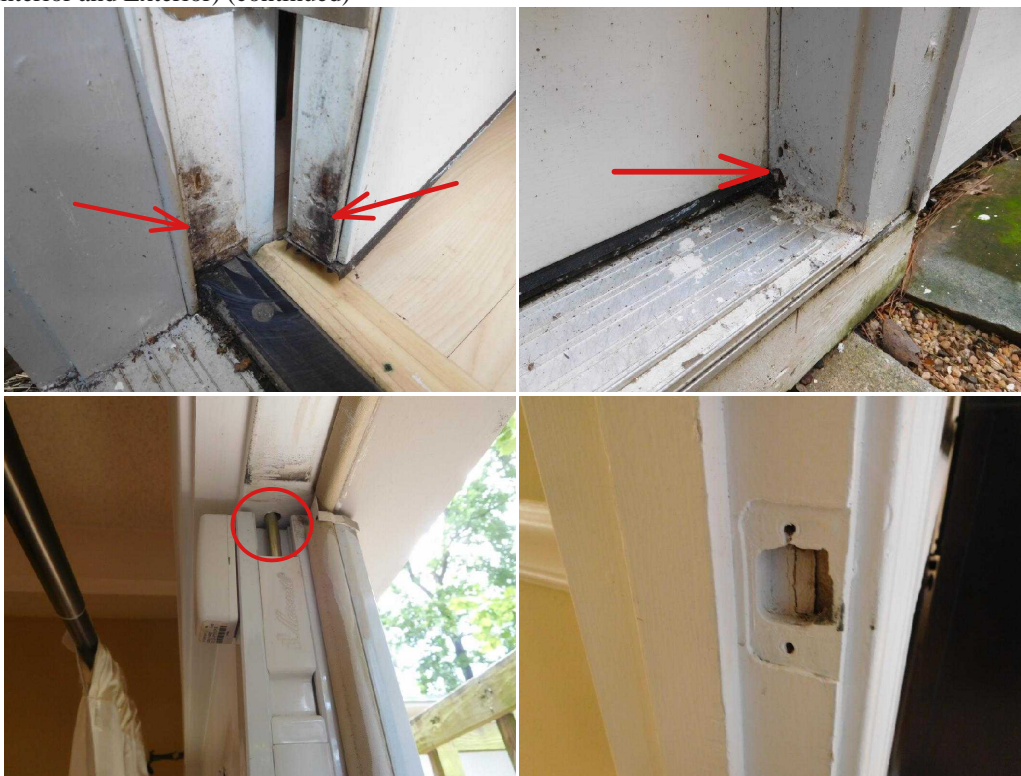
Deterioration due to moisture penetration were noted at the bottom edges of the door panel and exterior trim at the front door (see photos). Repair or replace damaged material as needed. The upper astragal bolt does not fully clear the bore hole and the secondary panel cannot open (see photo). Service or adjust as needed so the secondary panel can be opened.

The door to the master bedroom is binding/rubbing and the strike plate is missing (see photo). Adjust the door and replace the strike plate.

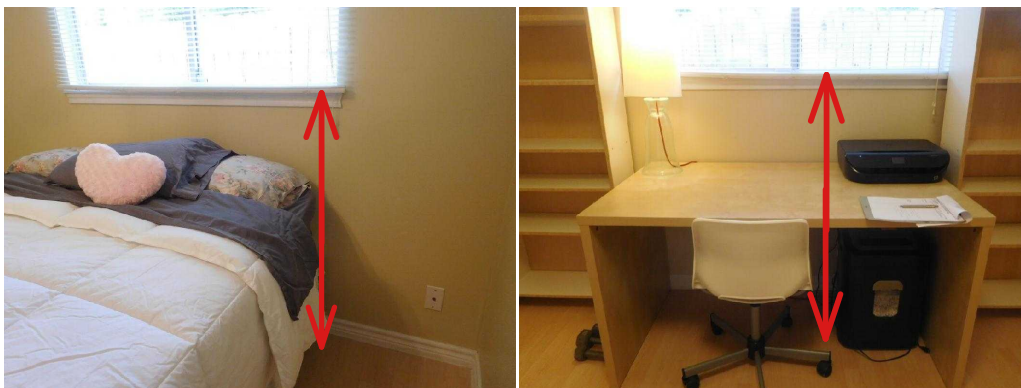
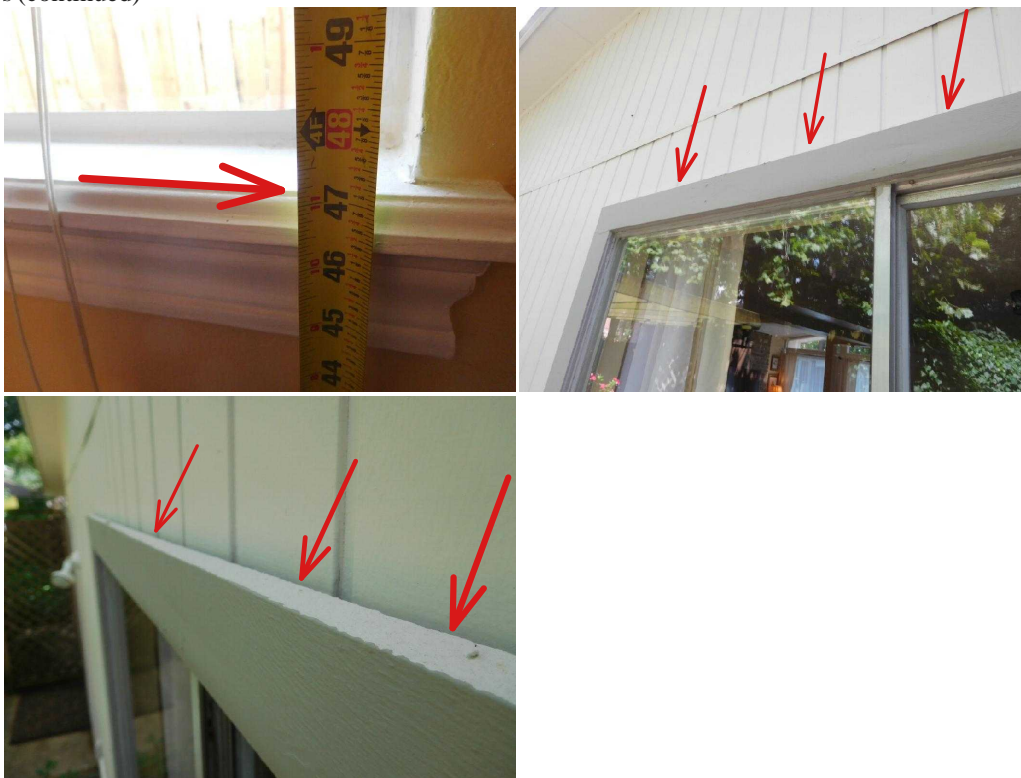
It was noted that the windows in the front two bedrooms are too high by current standards. Windowsill height in a bedroom should not exceed 44" so that the window may be used as an emergency egress. These sills are approximately 47" above the floor (see photos).

However, there is no drip cap flashing installed at the tops of the windows or back door (see photos). Properly installed drip cap flashing will prevent windows from leaking once the caulk has failed. Moisture entering at the tops of windows can go unnoticed for long periods of time and damage walls and siding materials. No signs of damage were noted at this time.

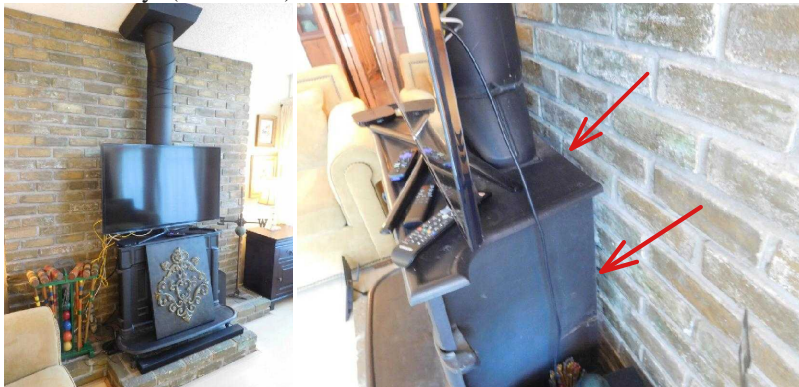
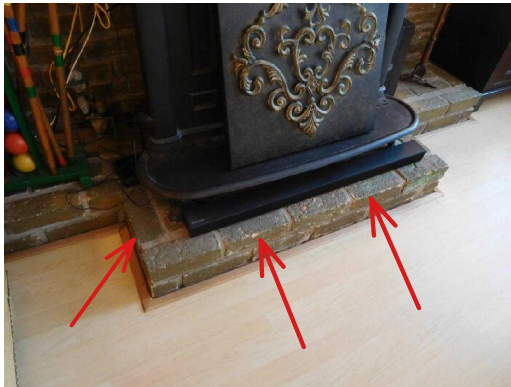
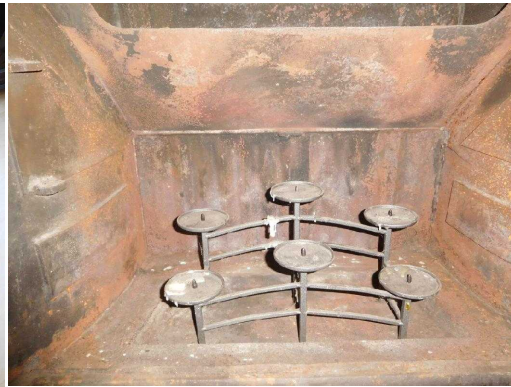
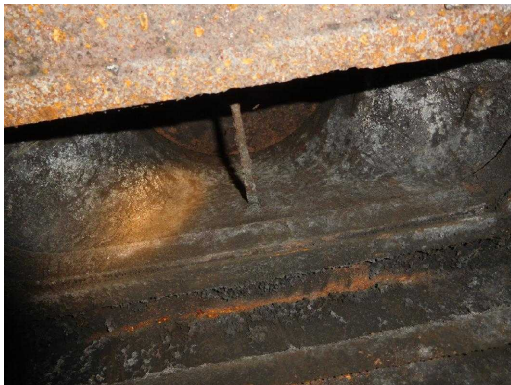
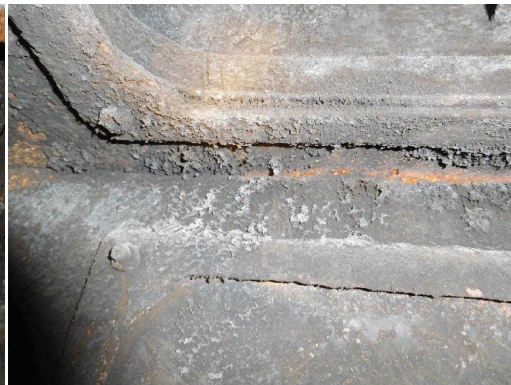
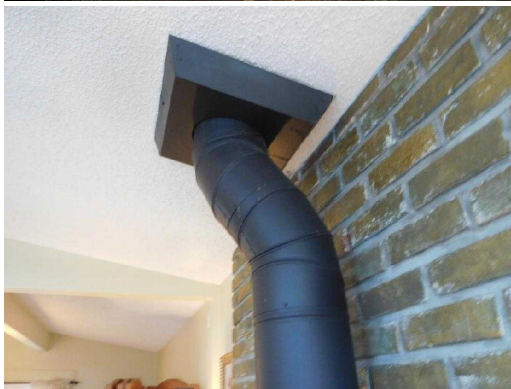
A small amount of oxidation and rust were noted in the firebox and chimney (see photo). Service as needed.

A buildup of soot and creosote was noted in the top of the firebox and chimney (see photo). Clean the chimney and firebox prior to use.

A qualified contractor is recommended to evaluate the firebox and chimney and estimate for repairs and upgrades.

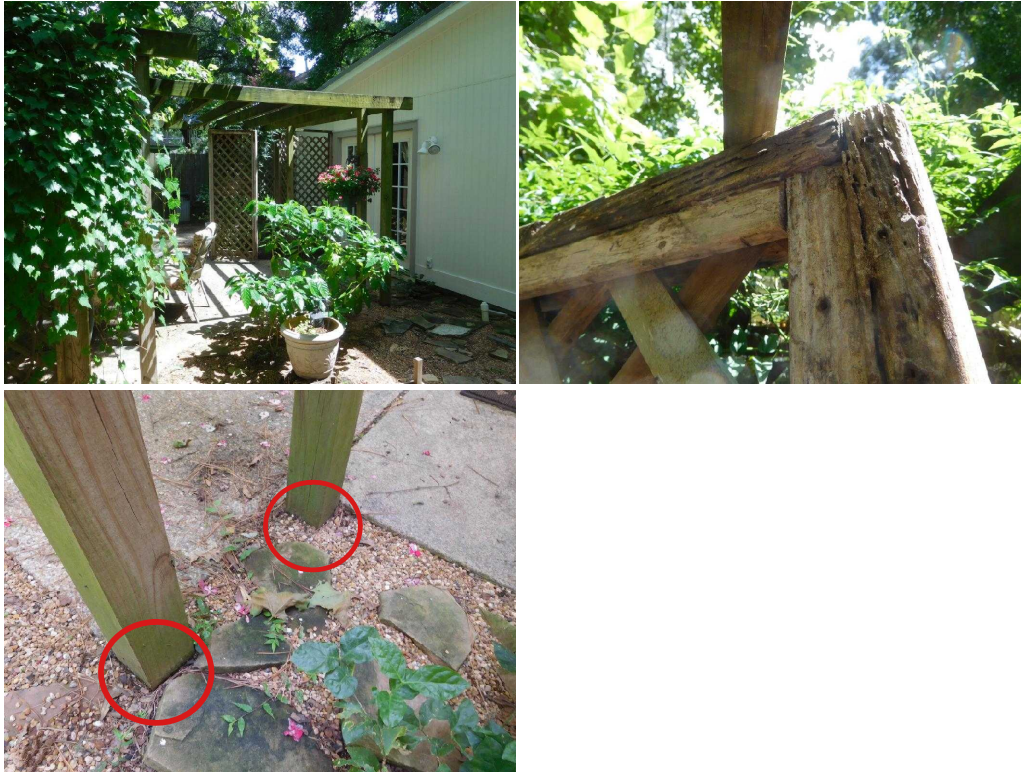
Grain splitting and deterioration were noted throughout (see photo). Repair/replace sections and periodically resecure components as needed.

Wood-to-ground contact was noted at sections along the perimeter of the deck (see photo). This can contribute to moisture penetration and damage and is also conducive to termite infestation.

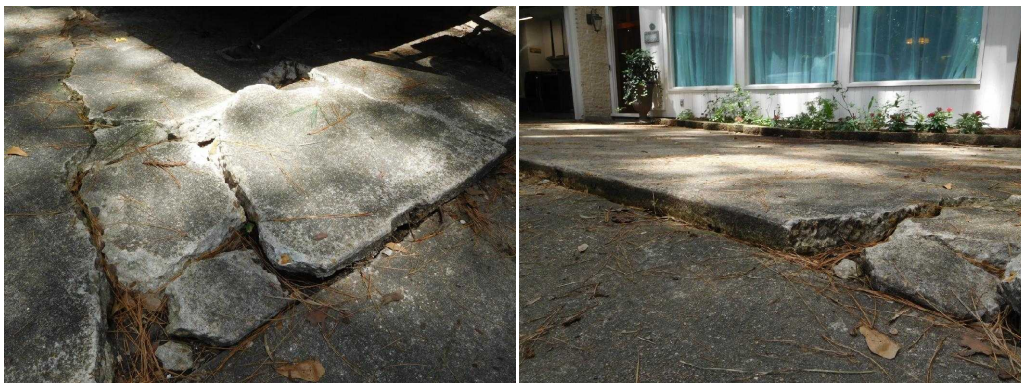
L. Other - Comments: The driveway is cracked and heaving sections have some degree of differential movement causing an uneven surface (see photos). This is a potential trip hazard. Repair or replace as needed.

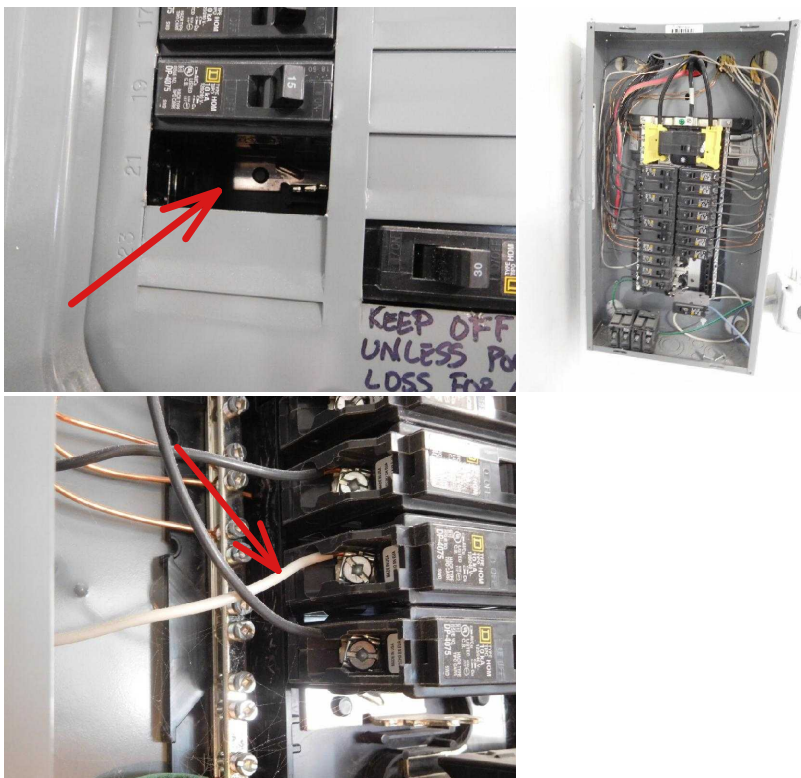
One of the metal knockouts is missing from the dead cover (see photo). Replace with a knockout cover approved for use with this panel so there is no gap.

However, the air conditioner condensing unit appears to be on a circuit with a 60 amp breaker. The nameplate on the unit calls for a maximum circuit breaker capacity of 45 amps. Have this circuit evaluated by a qualified electrical contractor and make any corrections deemed necessary.

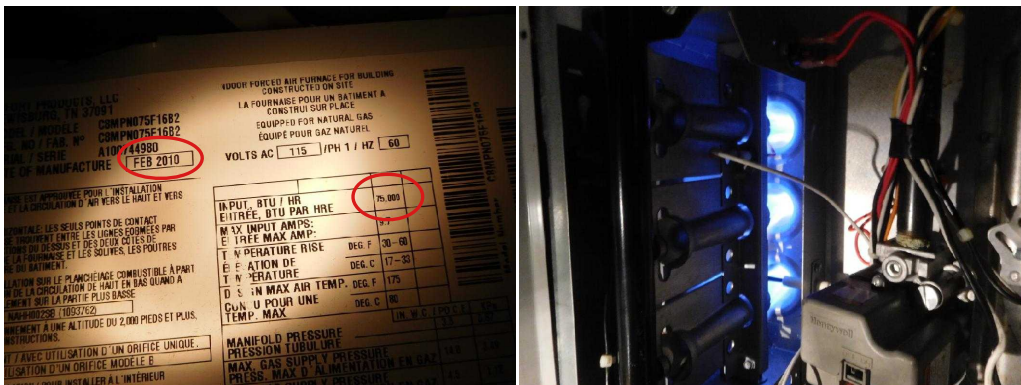
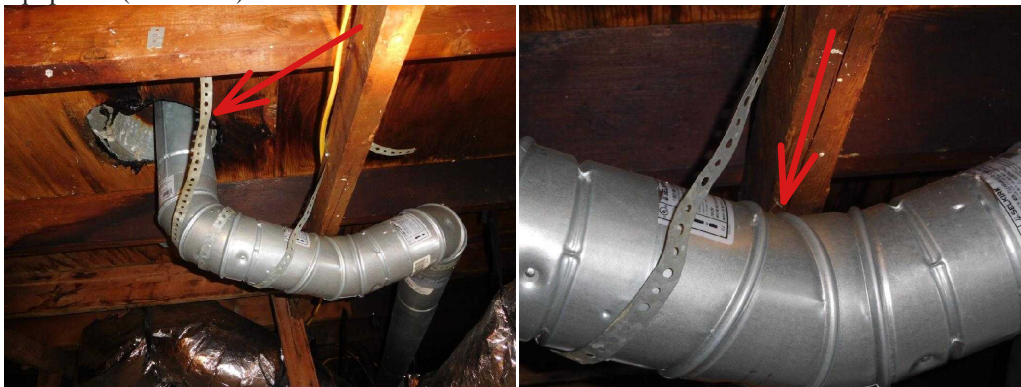
However, it was noted that the type 'B' metal exhaust vent is in too close of proximity to one of the wooden purlins and the roof decking at the point where it penetrates to the exterior (see photo). This vent needs to have a minimum of 1 inch clearance to all combustible materials in order to operate safely, as per manufacturer's specifications.

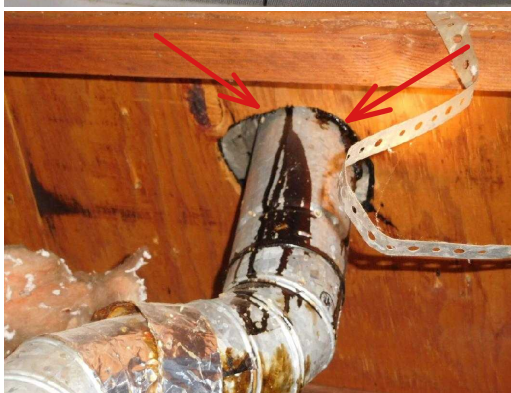
It was noted that the metal exhaust vent is in too close of proximity to the wooden roof decking at the point where it penetrates the roof (see photo). This type 'B' metal vent needs to have a minimum of a 1 inch clearance to all combustable materials in order to operate safely. I recommend having a qualified contractor assess this condition and make the necessary correction. Properly install approved metal support strapping to secure the vent between the adjacent rafters.

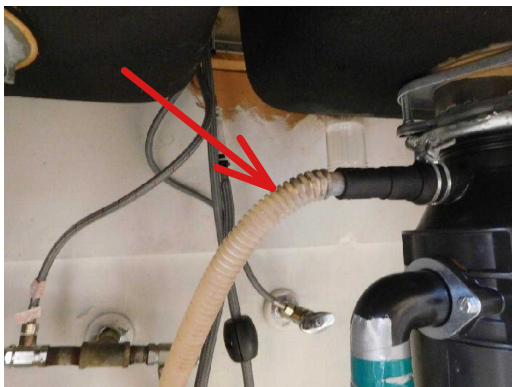
However, I recommend properly looping the drain hose up to the bottom of the counter top and then back down to the disposal/drain line (see photo). This will help prevent any back-flow from occurring during draining.

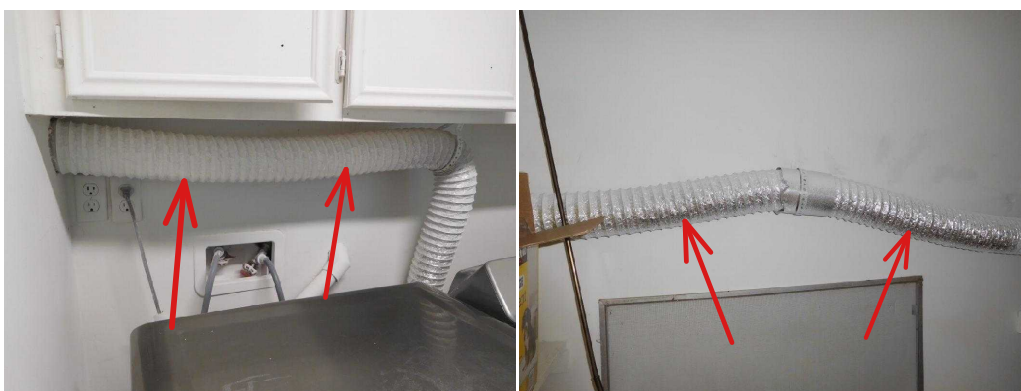
H. Dryer Exhaust Systems - Comments: The flexible section of the dryer vent behind the unit is comprised of a lightweight flexible mylar foil section of ductwork (see photos). This material is not recommended for dryer vents unless a UL listing label is present. Flex ducts are not permitted in concealed spaces such as a crawlspace and may not be run through walls or other barriers. Flexible vent connections also should not exceed 8' in length. Properly install a rigid metal dryer vent as per code and safety. Replace the flexible section of the vent with a section of flexible metal ductwork approved for use as a dryer vent.

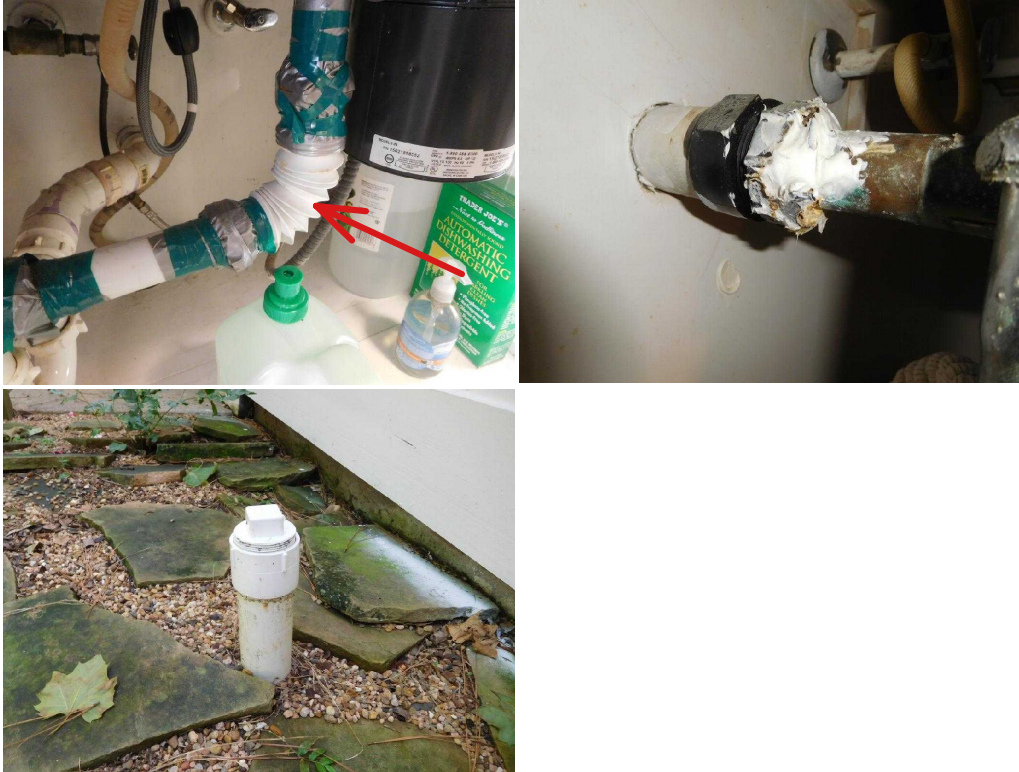
B. Drains, Wastes, and Vents A leak was noted in the drain line under the kitchen sink. An amateur repair with tape has been made on the drain pipe (see photo). A section of flexible pipe is also present in the drain line under the sink (see photo). This type of drain line is more prone to clogging and I recommend replacing the flex pipe with a section of smooth-wall PVC. Properly repair the drain line.
