PROPERTY INSPECTION REPORT

Prepared For: Xxxxx and Xxxxx XXXXXXXXXXXX
Concerning: XXXX Fairgate Dr. Houston, Texas 77094
Inspection Date: 06/15/2019

By: Inspector Name: Chris Oelfke License Number: 8021 Date: 06/16/2019
Signature:
Phone: 713-498-9896 E-Mail: coelfke@earthlink.net

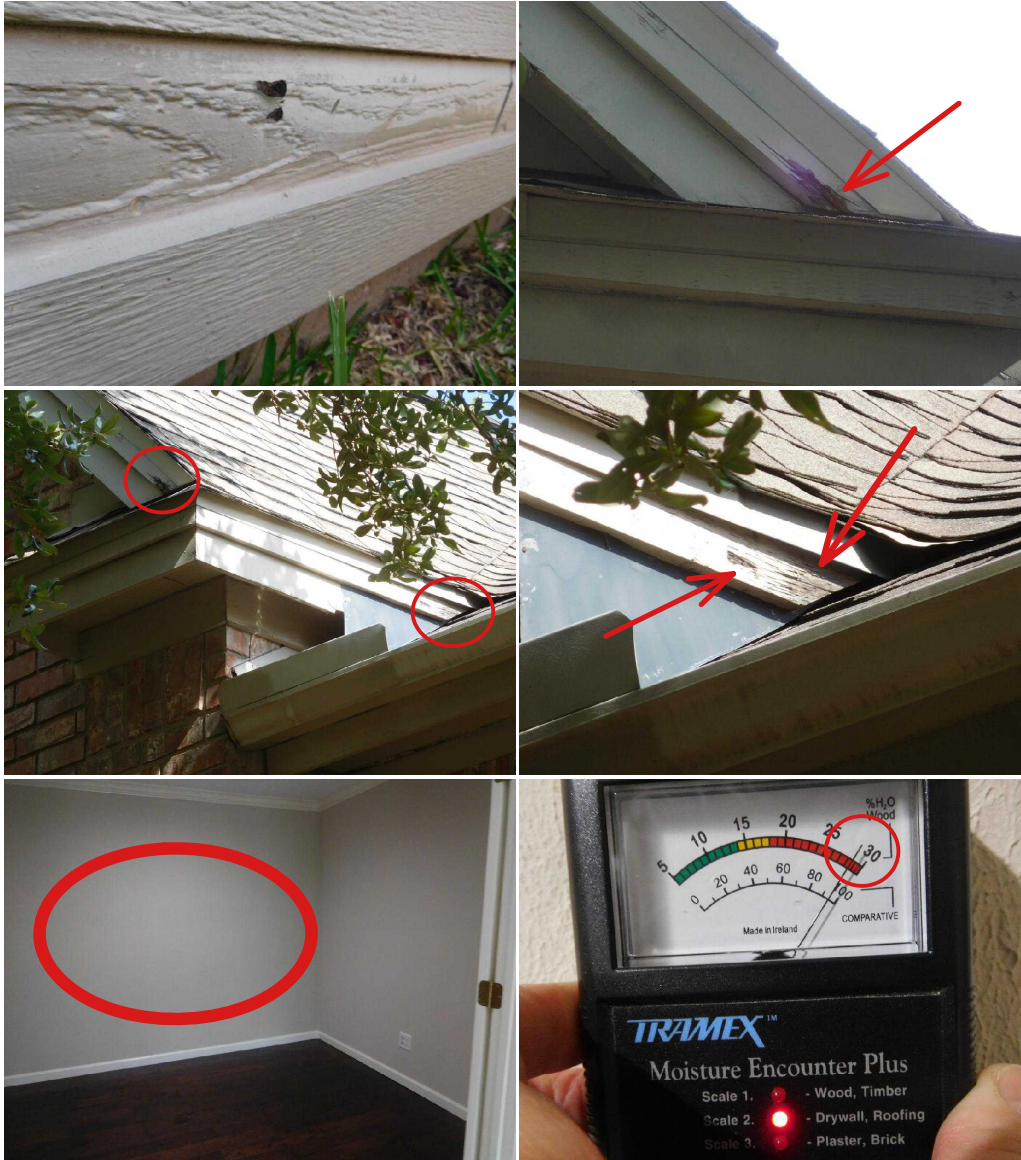
E. Walls (Interior and Exterior) (continued)

However, deterioration due to moisture penetration was noted at the bottom edges of a few sections of the composition siding at the exterior, such as on the garage (see photos). Repair or replace exterior siding as needed.

Grain splitting and minor deterioration due to moisture penetration were noted at the ends of the wooden fascia board trim at various locations (see photos). Repair or replace exterior trim as needed.

Elevated moisture content was noted in the drywall in the upstairs bonus room (see photos). This appears to be the result of a leak in the attic space above, possibly a roof leak at the valley. Once the leak is located and repaired replace wet and damaged material as needed. Moisture readings were made using a non-destructive moisture meter.

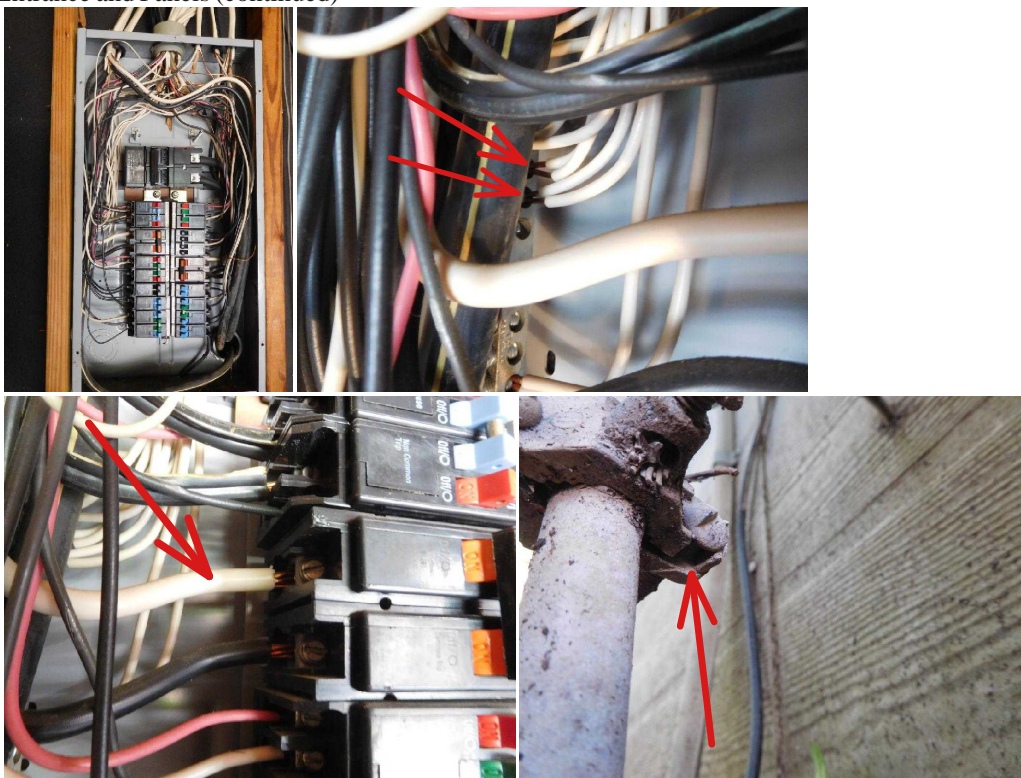
A. Service Entrance and Panels (continued)

It is recommended that an anti-oxidant gel be applied to the aluminum service lines where they are secured to the contact lugs (see photo). This will prevent corrosion from occurring at these connections.

However, it was noted that a few of the neutral wires have been improperly double-tapped on the neutral bus bar with two wires secured under one contact (see photo). Move neutral double tapped wire to separate and single tapped lugs at the neutral bus or ground bus bar as required in a panel box.

Label white neutral wire used as "hot" wire red or black to denote "hot" wire at breakers in panel box (see photo). The lack of proper labeling does not affect the conductivity of the wiring or safety for everyday use and is not considered a major deficiency.

The metal clamp that secures the grounding electrode to the ground rod is broken (see photo). Replace the clamp and ensure that the grounding system is installed as per code and safety.

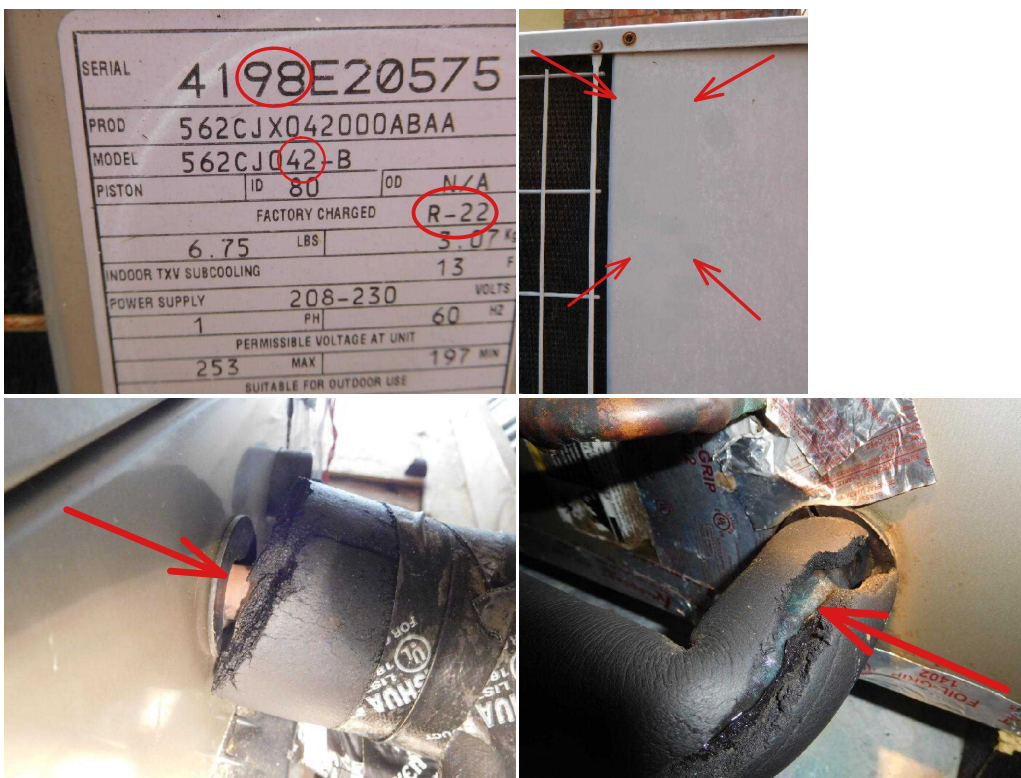
Small gaps were noted in the foam tube insulation on the low pressure refrigerant (suction) lines where they enter the walls of the evaporator coil cases in the attic spaces (see photos). Properly insulate all lengths of these lines to prevent the formation of condensation in the attic spaces and walls.

A qualified HVAC contractor is recommended to evaluate each system and estimate for service or replacement.

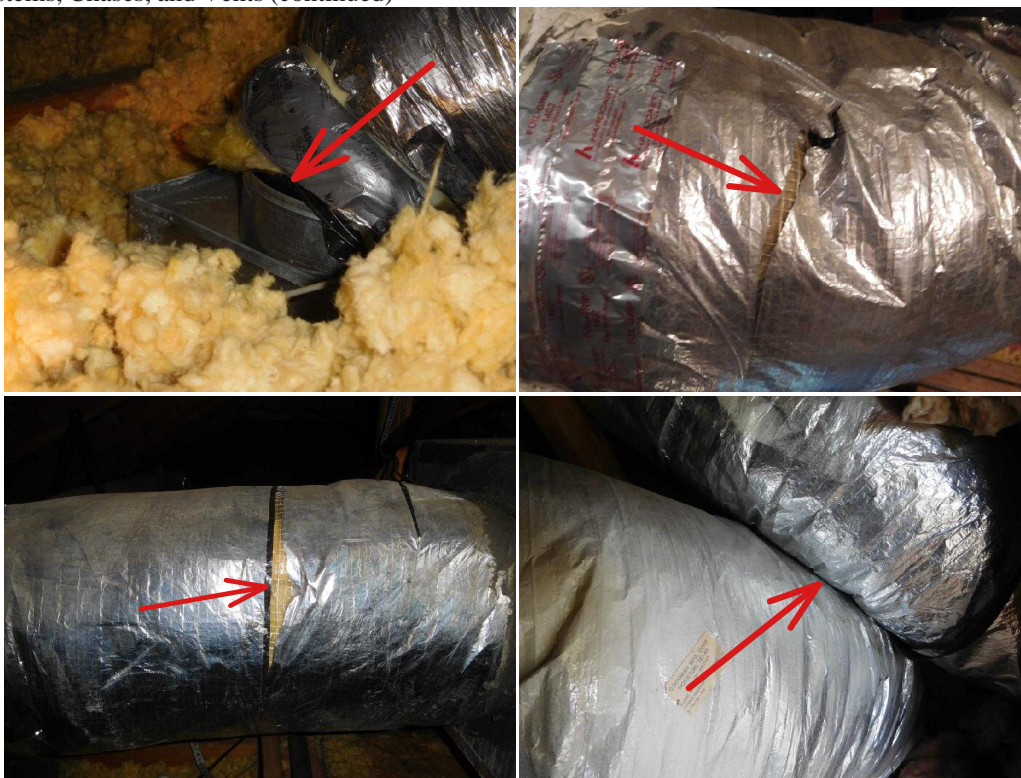
C. Duct Systems, Chases, and Vents (continued)

However, one of the ducts is disconnected from the register (above the upstairs bonus room, see photo). Properly connect the duct and insulate the register.

It was noted that some sections of ductwork are in direct contact with each other (see photo). This contact can cause condensation to form on the surfaces of the ductwork. I recommend separating sections from one another or placing insulation material between sections so that there is no direct contact.

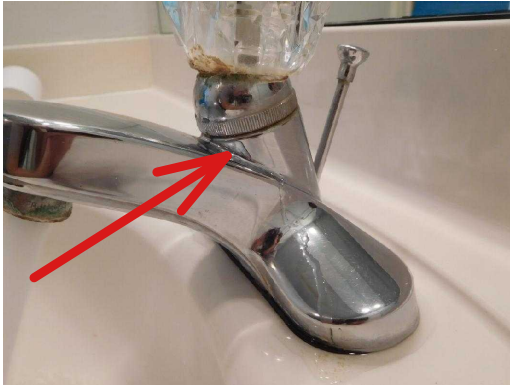
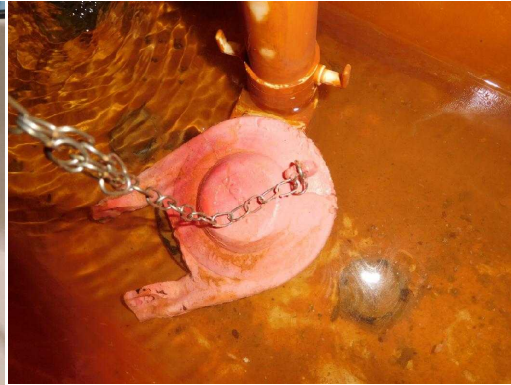
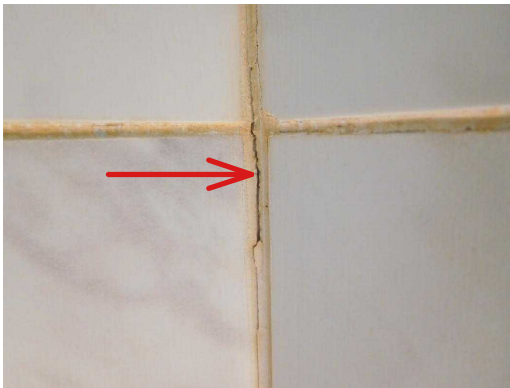
A. Plumbing Supply, Distribution Systems and Fixtures (continued)

A leak was noted at the faucet handle at the sink on the west side of the upstairs bathroom (see photo). Repair/replace.

The flapper in the master bathroom toilet tank was detached, is in poor condition, and needs to be replaced (see photo).

Small separation gaps were noted in the grout lines in the tile shower enclosures (see photo). Seal where needed.

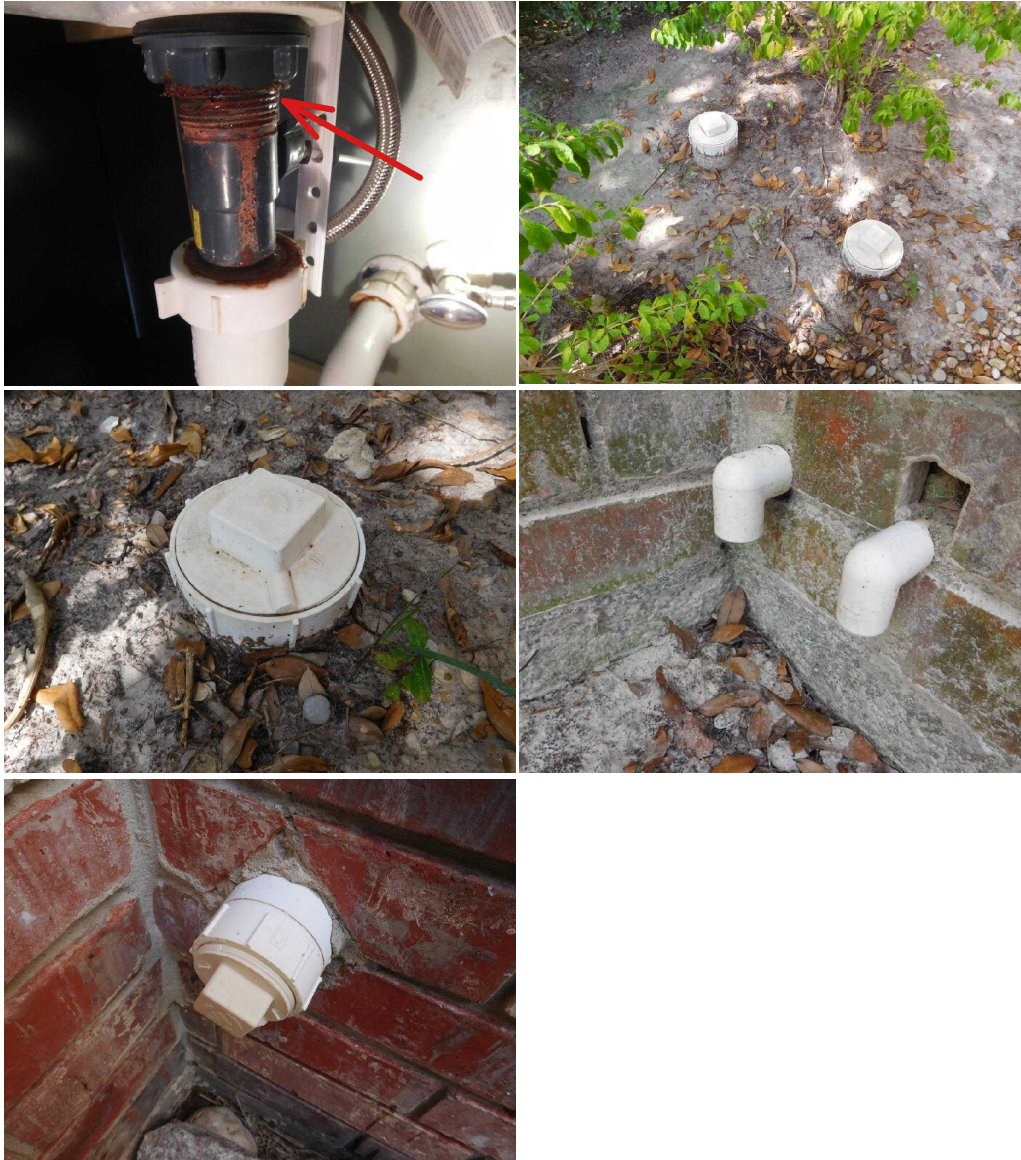
B. Drains, Wastes, and Vents (continued)

However, leaks were noted in the drain lines under the right hand master bathroom sink and half bathroom sink (see photo). Repair.

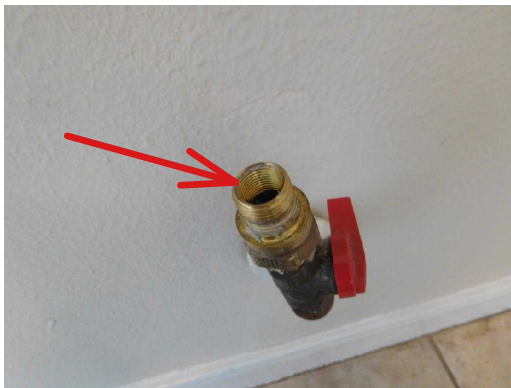
Unless a natural gas fired dryer is going to be installed in the laundry room, the natural gas supply line should be capped using an approved cap (see photo).

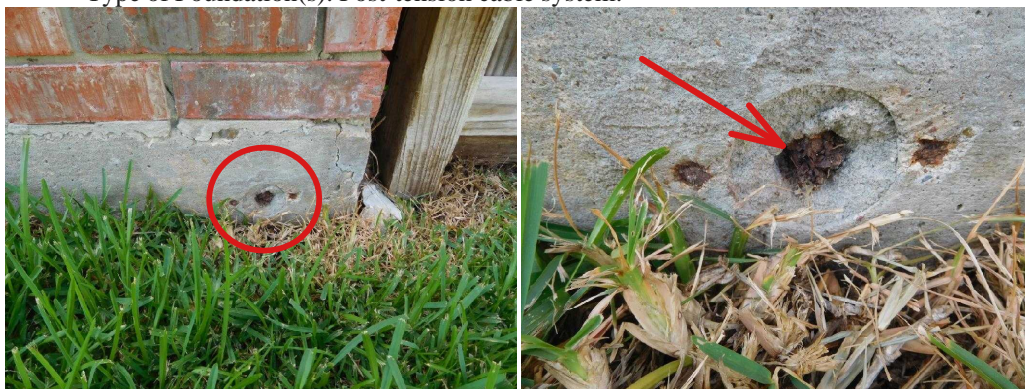
However, high soil/low footing was noted at the perimeter of the foundation at the garage (see photos). A 5 to 7 inch clearance between the soil and the top of the slab is adequate. Clearances less than this range create conditions considered conducive to termite infestation and moisture penetration.

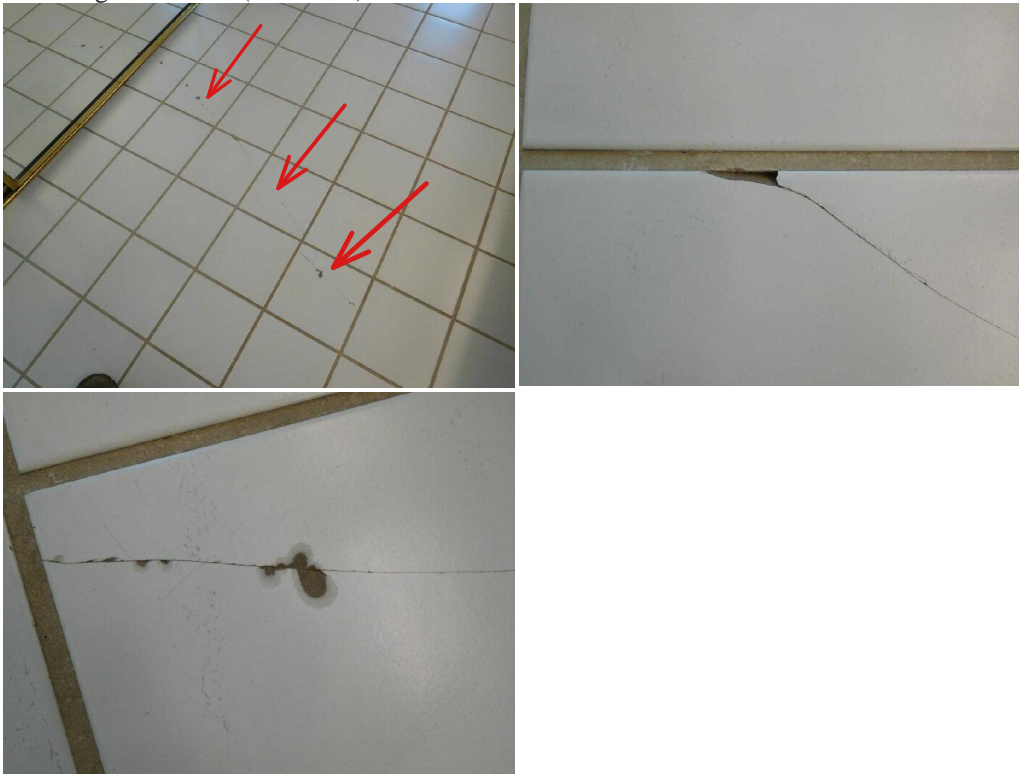
F. Ceilings and Floors (continued)

However, cracked tiles were noted in the floor in the master bathroom (see photos). Replace as needed.

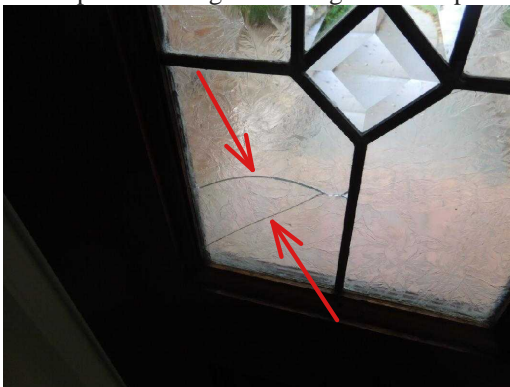
However, a section of cracked glass was noted in the front door glazing (see photo). Re-glaze as needed.

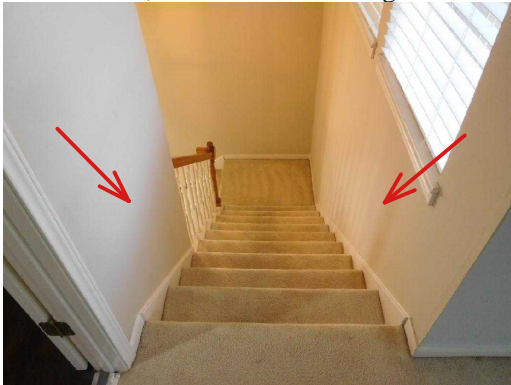
However, there is no handrailing installed at the top portion of the staircase (see photo). Install handrailing as per code and safety.

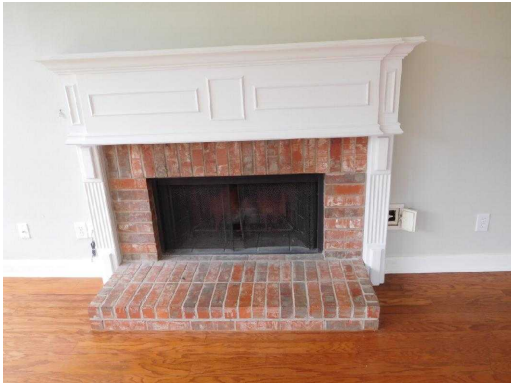
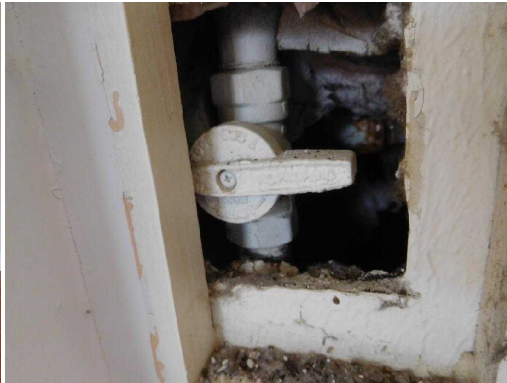
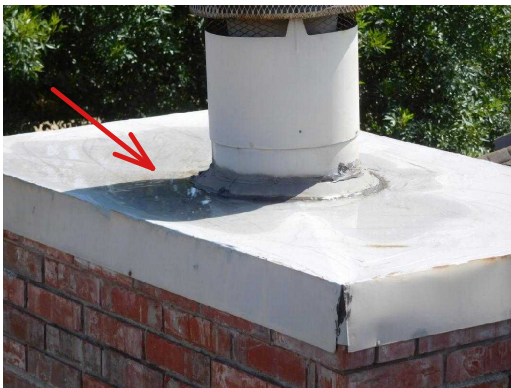
I recommend installing a new valve that requires a valve key to operate the gas supply line as a safety precaution (see photo).

Standing water was noted on top of the chimney crown (see photo). Adjust as needed so the crown properly sheds water.

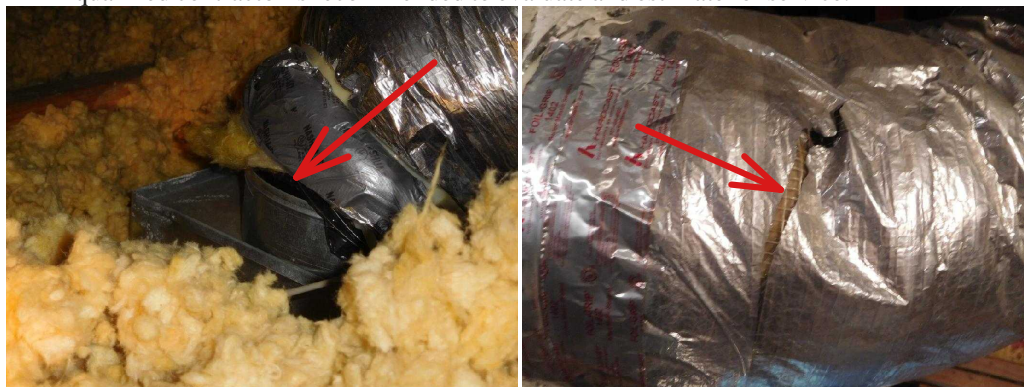
However, one of the ducts is disconnected from the register (above the upstairs bonus room, see photo). Properly connect the duct and insulate the register.

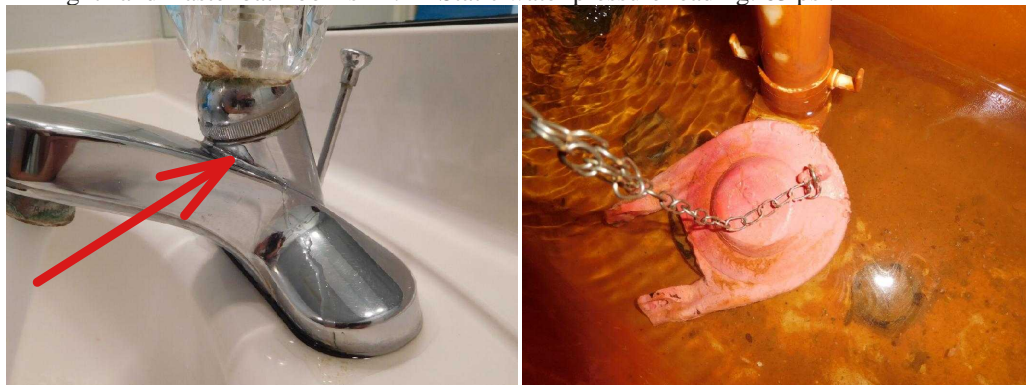
A leak was noted at the faucet handle at the sink on the west side of the upstairs bathroom (see photo). Repair/replace.

The flapper in the master bathroom toilet tank was detached, is in poor condition, and needs to be replaced (see photo).

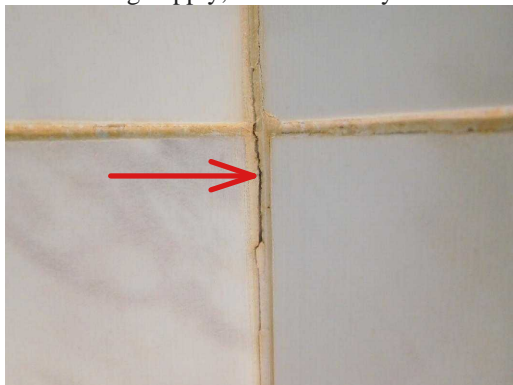
Small separation gaps were noted in the grout lines in the tile shower enclosures (see photo). Seal where needed.

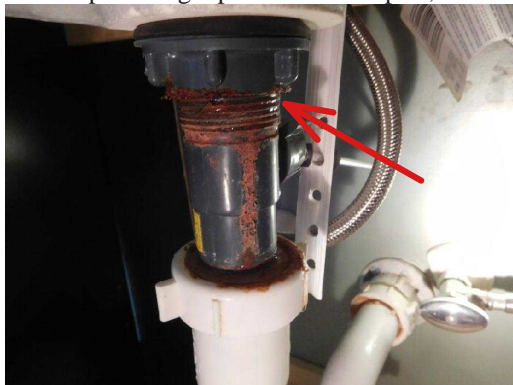
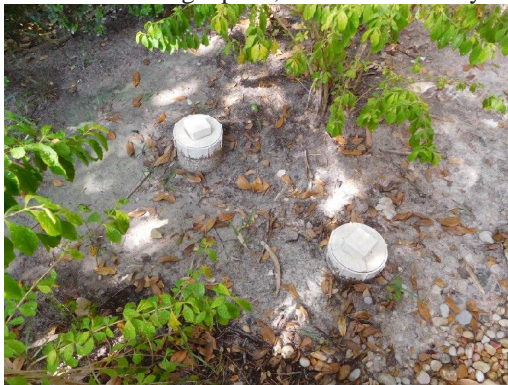
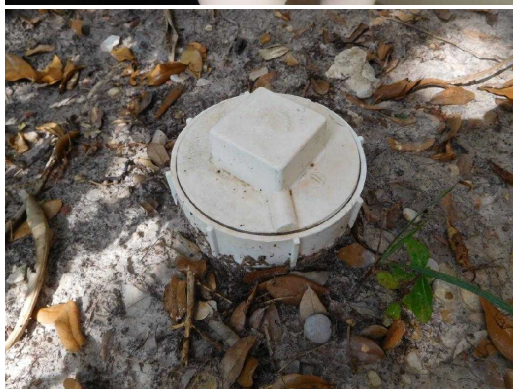
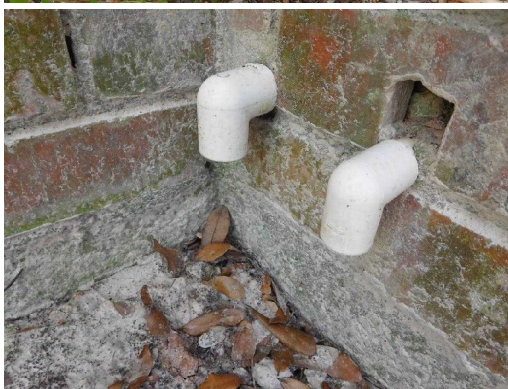
However, leaks were noted in the drain lines under the right hand master bathroom sink and half bathroom sink (see photo). Repair.

Paint the exterior PVC cleanout caps and drains where needed (see photos).

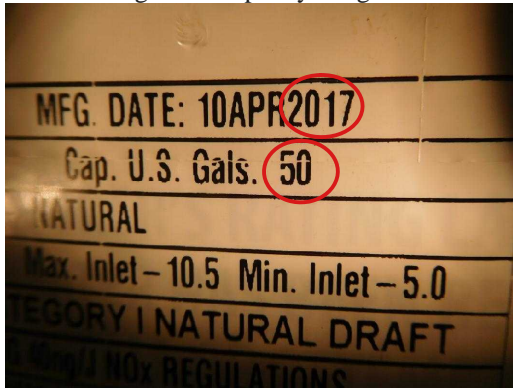
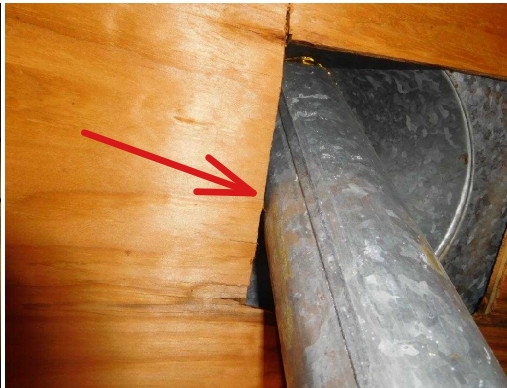
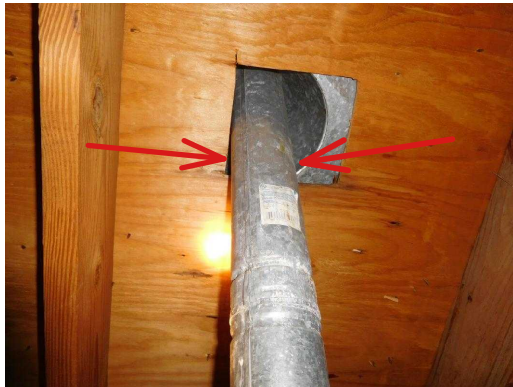
However, it was noted that the metal exhaust vent is in too close of proximity to the wooden roof decking at the point where it penetrates the roof (see photo). This type 'B' metal vent needs to have a minimum of a 1 inch clearance to all combustibles in order to operate safely. I recommend having a qualified contractor assess this condition and make the necessary correction.

Properly install approved metal support strapping to secure the vent between the adjacent rafters (see photo). Energy Source: Natural gas. Capacity: 50 gallon.

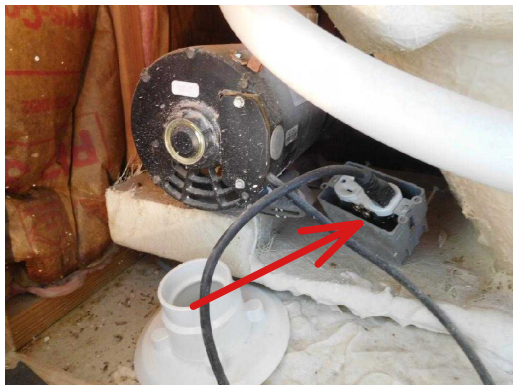
However, it was noted that the tub's electric pump outlet is resting on the sub-floor under the tub (see photo). I recommend securely mounting this outlet on one of the framing cripples of the tub surround so that it is up off of the floor. Replace the missing faceplate on the outlet.

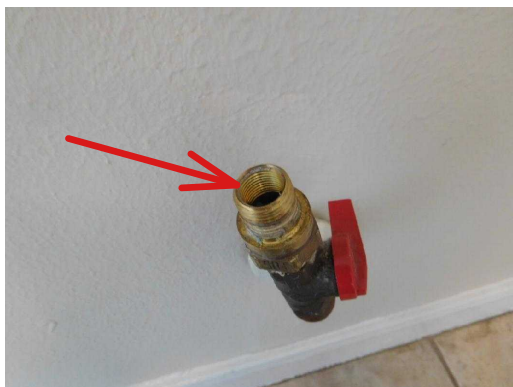
Unless a natural gas fired dryer is going to be installed in the laundry room, the natural gas supply line should be capped using an approved cap (see photo).

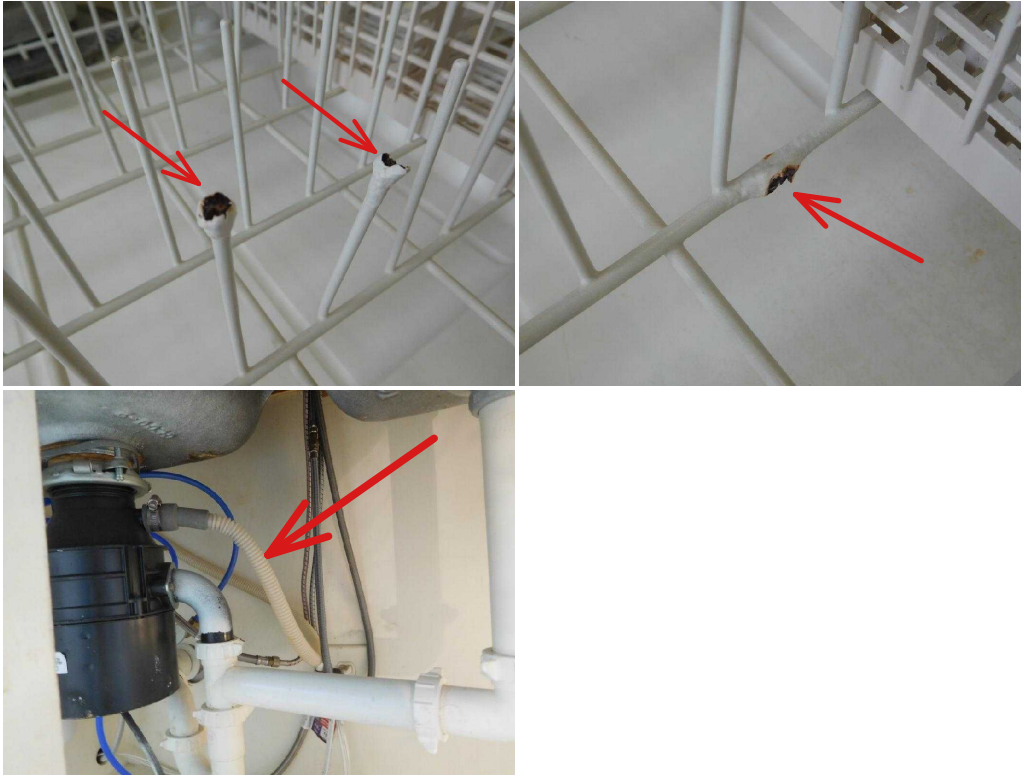
Some rust was noted on the tines of the dish racks (see photos). Reseal or replace if desired.

I recommend properly looping the drain hose up to the bottom of the counter top and then back down to the disposal/drain line (see photo). This will help prevent any back-flow from occurring during draining.

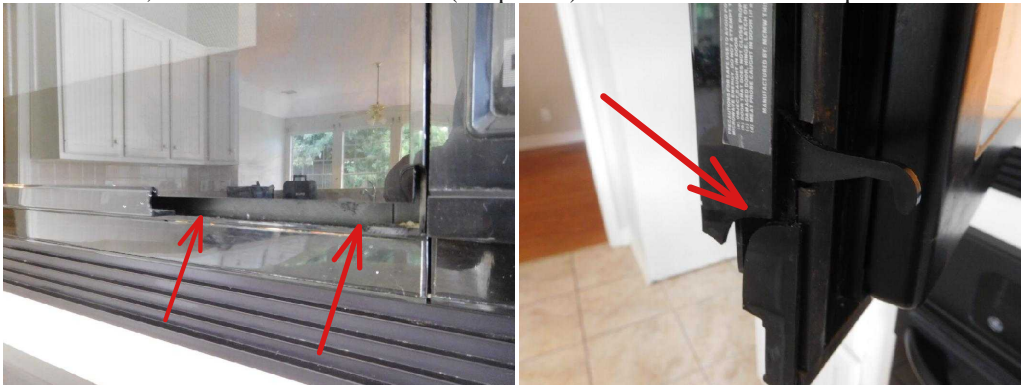
However, the door is cracked/broken (see photos). Service as needed or replace the microwave.

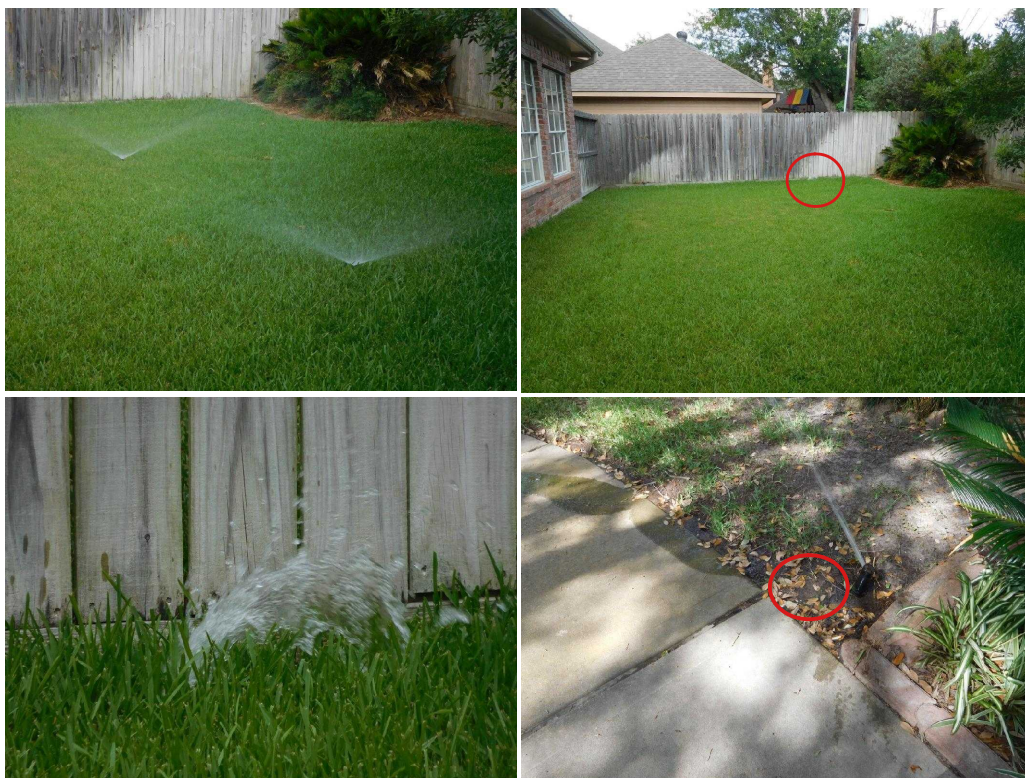
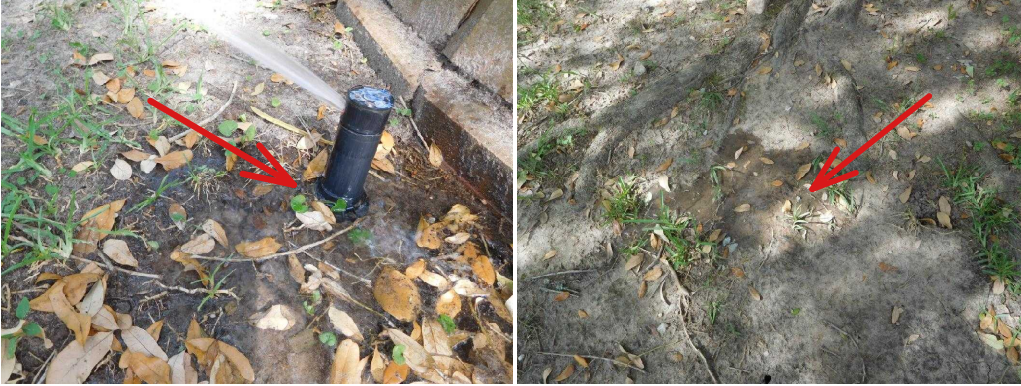
However, some of the spray heads are damaged, partially missing, or are simply not level and need to be repaired/replaced or adjusted. Leaks were noted at a few locations (see photos).

Due to the majority of the system being underground and the difficult task of locating pop-up heads that do not pop up, I do not include the entirety of these systems in the inspection. No pressure test or any type of leak testing were performed at this time. I recommend contacting a qualified and reputable irrigation system contractor to assess and service the system as needed. Periodically adjust the spray heads as needed so that water is directed in the intended direction.
