PROPERTY INSPECTION REPORT

Prepared For: XXXXXXXX XXXXXX
Concerning: XXXXX Wild Oaks Dr. Houston, Texas 77090
Inspection Date: 07/01/2019
By: Inspector Name: Chris Oelfke License Number: 8021 Date: 07/02/2019
Signature:
Phone: 713-498-9896 E-Mail: coelfke@earthlink.net

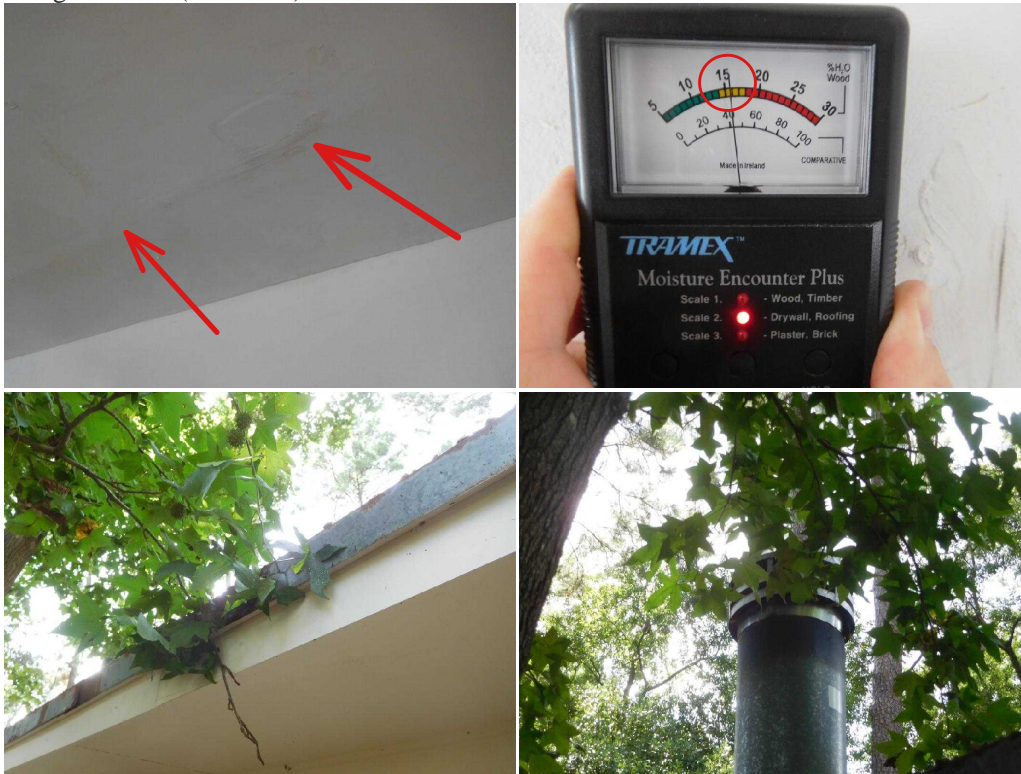
C. Roof Covering Materials (continued)

Comments: Built-up Tar and Gravel. Many areas of the roof have asphalt coating that is exposed and is oxidized, shrinking back, and cracked (see photos). Many areas have thinly applied/missing gravel.

Exposed roofing felt and its fiberglass mat was noted along the roof's peaks (see photos).

Some of the drip edge flashing is oxidized and rusting (see photo).

Stains were noted at the underside of the wooden roof sheathing (viewed in the attic space). Stains, patched/repared sections and elevated moisture levels were noted at the garage ceiling (see photos). Moisture readings were made using a non-destructive moisture meter.

A qualified roofing contractor is recommended to evaluate the roof and estimate for repairs or replacement.

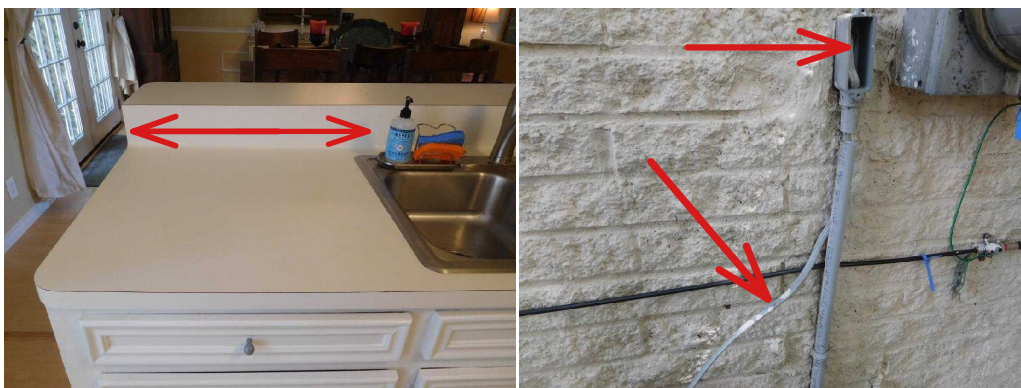
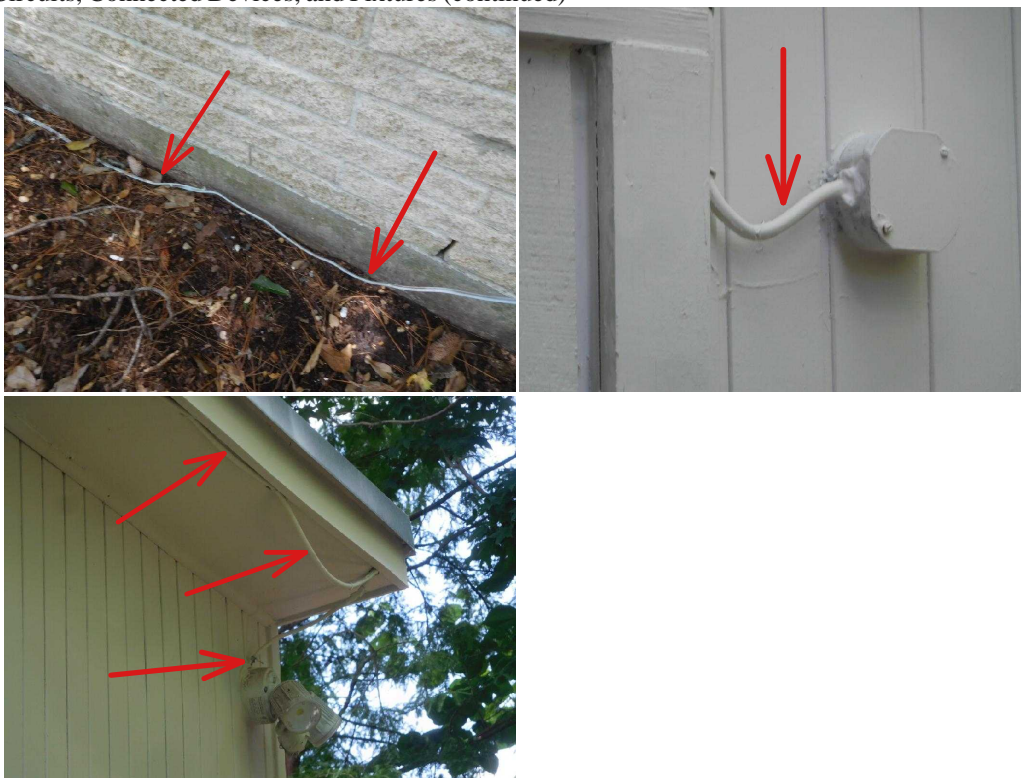
B. Branch Circuits, Connected Devices, and Fixtures (continued)

Exposed exterior electrical wiring was noted running along the north side of the house and resting on the ground and also at the back patio (see photos). All exterior electrical wiring should be properly secured in approved protective conduits as per code and safety.

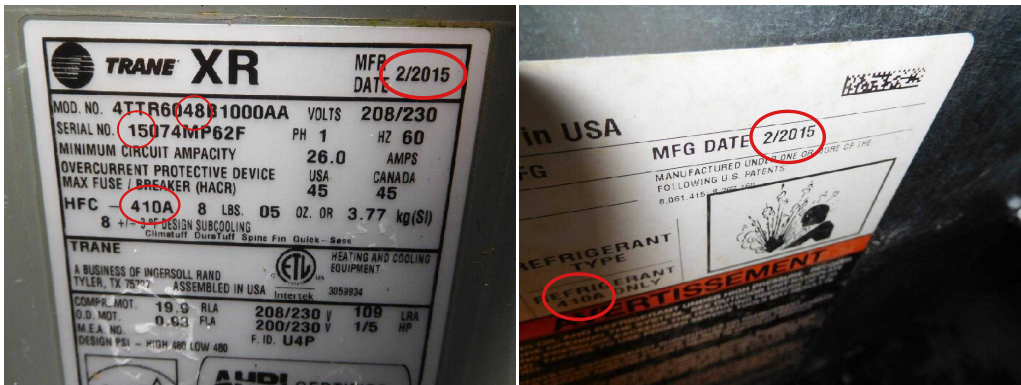
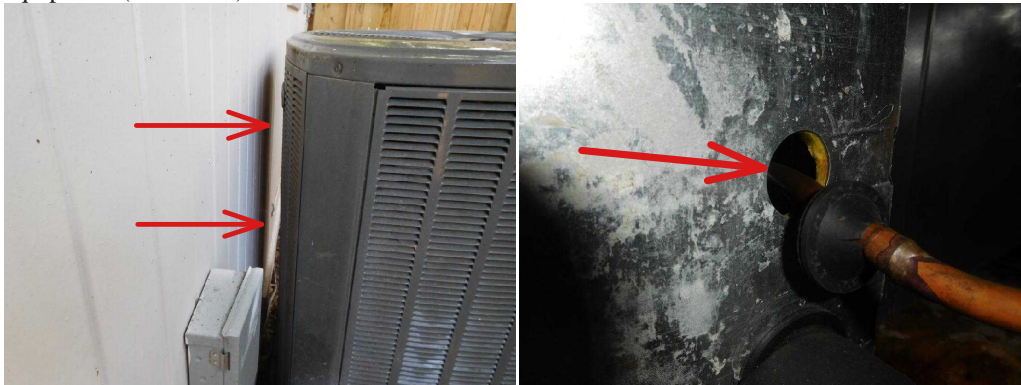
B. Cooling Equipment (continued)

A small gap was noted where the refrigerant line enters the wall of the evaporator coil case in the attic (see photo). Properly seal openings in the coil case to prevent air leaks and the formation of excess condensation in the attic space.

A qualified HVAC contractor is recommended to evaluate the system and estimate for service.

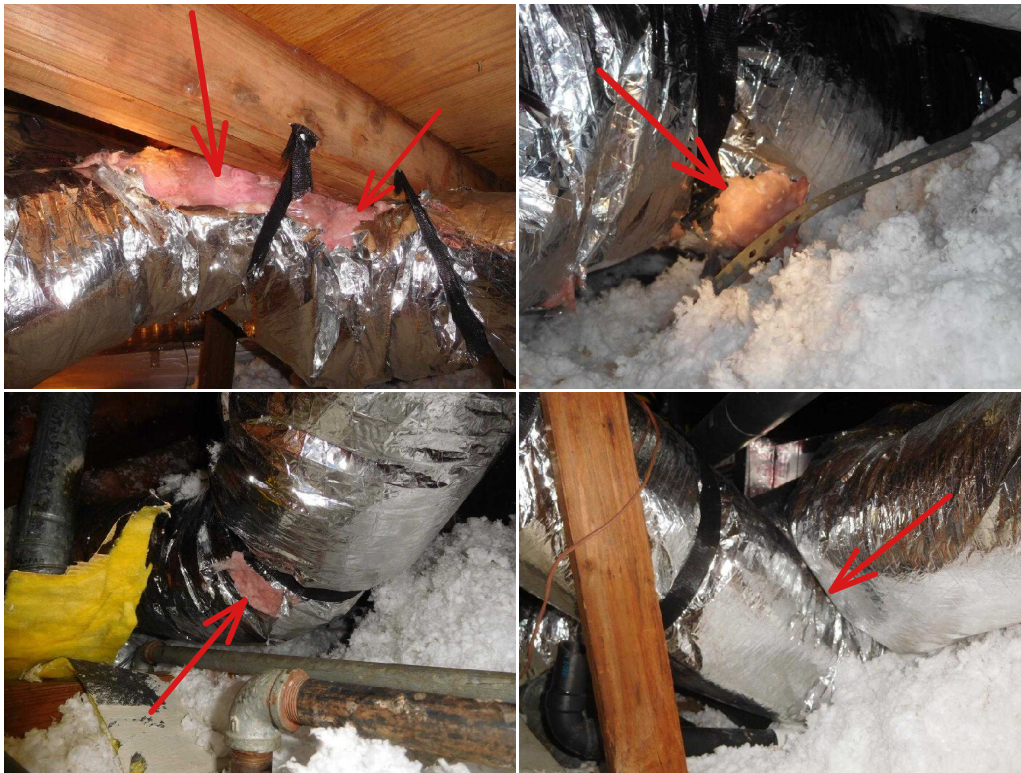
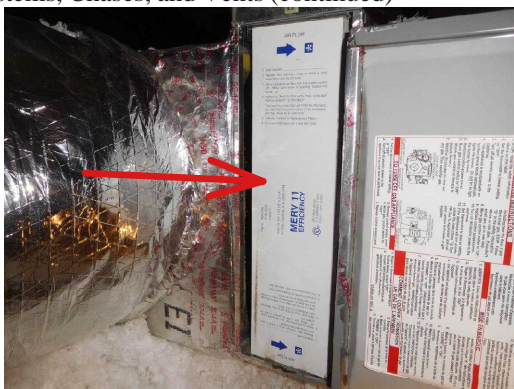
C. Duct Systems, Chases, and Vents (continued)

However, a few sections of ductwork have tears in the outer sheathing and some of the insulation layer is exposed (see photo). Seal these sections where needed.

A media filter is in place at the air handler in the attic (see photo). Change the filter on a regular basis as per the manufacturer's specifications. Do not install filters in the air return grills in the living space as long as the media filter is in place.

A qualified contractor is recommended to evaluate and estimate for service/repairs.

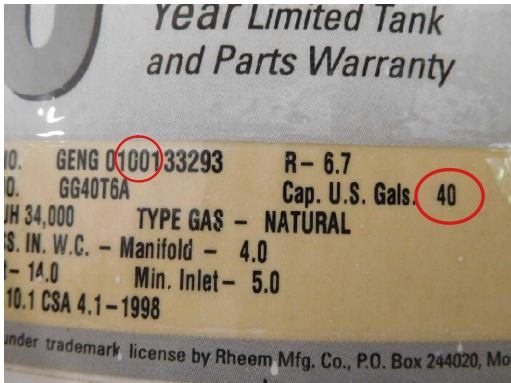
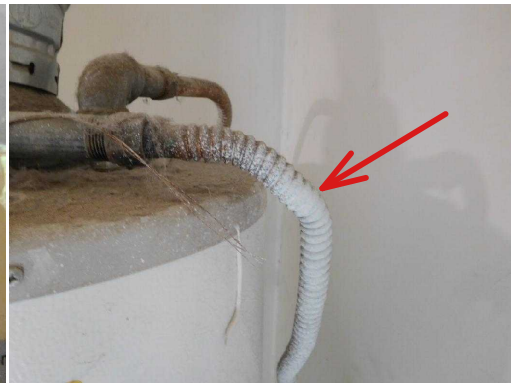
A section of the temperature pressure relief drain line is comprised of a corrugated flexible tube (see photo). Replace with a smooth wall pipe such as 3/4" CPVC.

It was noted that the metal exhaust vent is in too close of proximity to the wooden roof decking at the point where it penetrates the roof (see photo). This type 'B' metal vent needs to have a minimum of a 1 inch clearance to all combustable materials in order to operate safely. I recommend having a qualified contractor assess this condition and make the necessary correction. Properly install approved metal support strapping to secure the vent between the adjacent rafters.

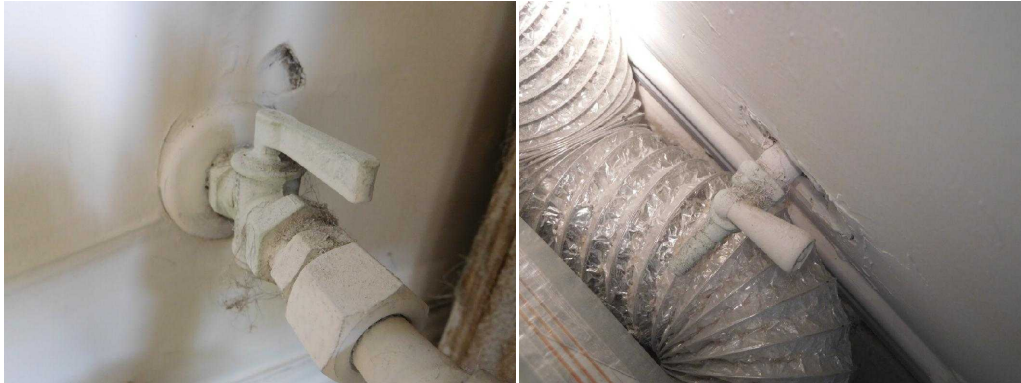
Unless a natural gas fired dryer is going to be installed in the laundry room, the natural gas supply line should be capped using an approved cap (see photo).

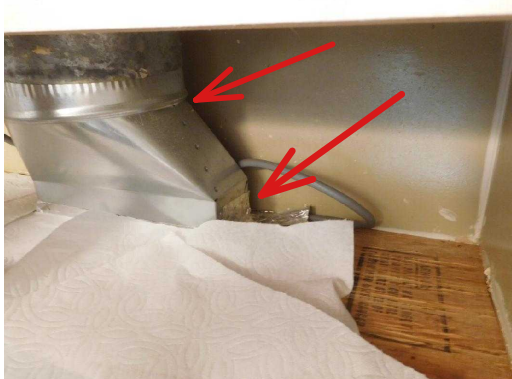
However, gaps were noted in the duct and air is leaking into the cabinet above the unit. Properly seal the duct as needed.

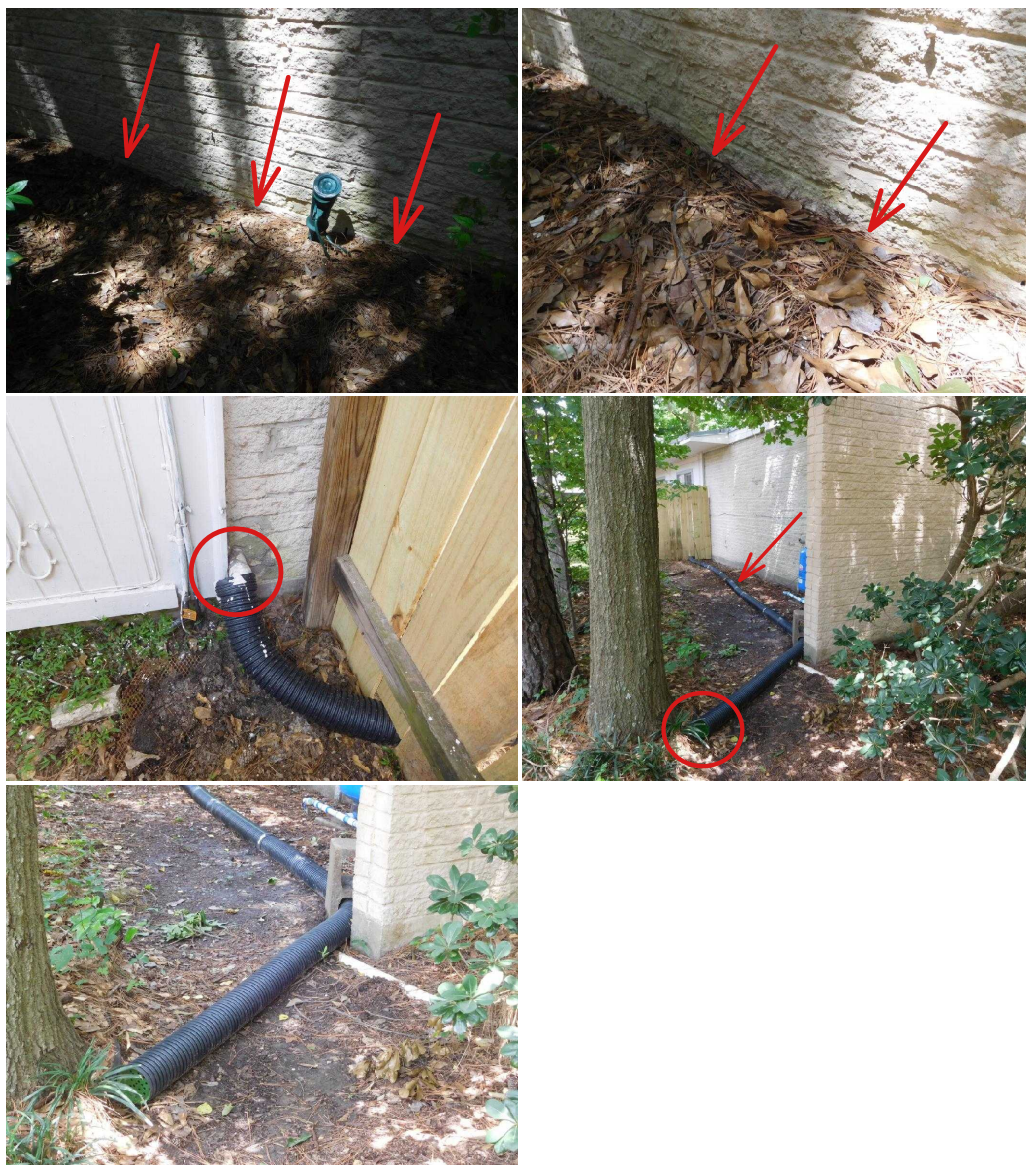
What appears to be a roof scupper/drain was not tested at this time (see photo). I was unable to locate the top of the scupper or drain at the roof surface. Periodically clean out the drains as needed so that positive drainage occurs.

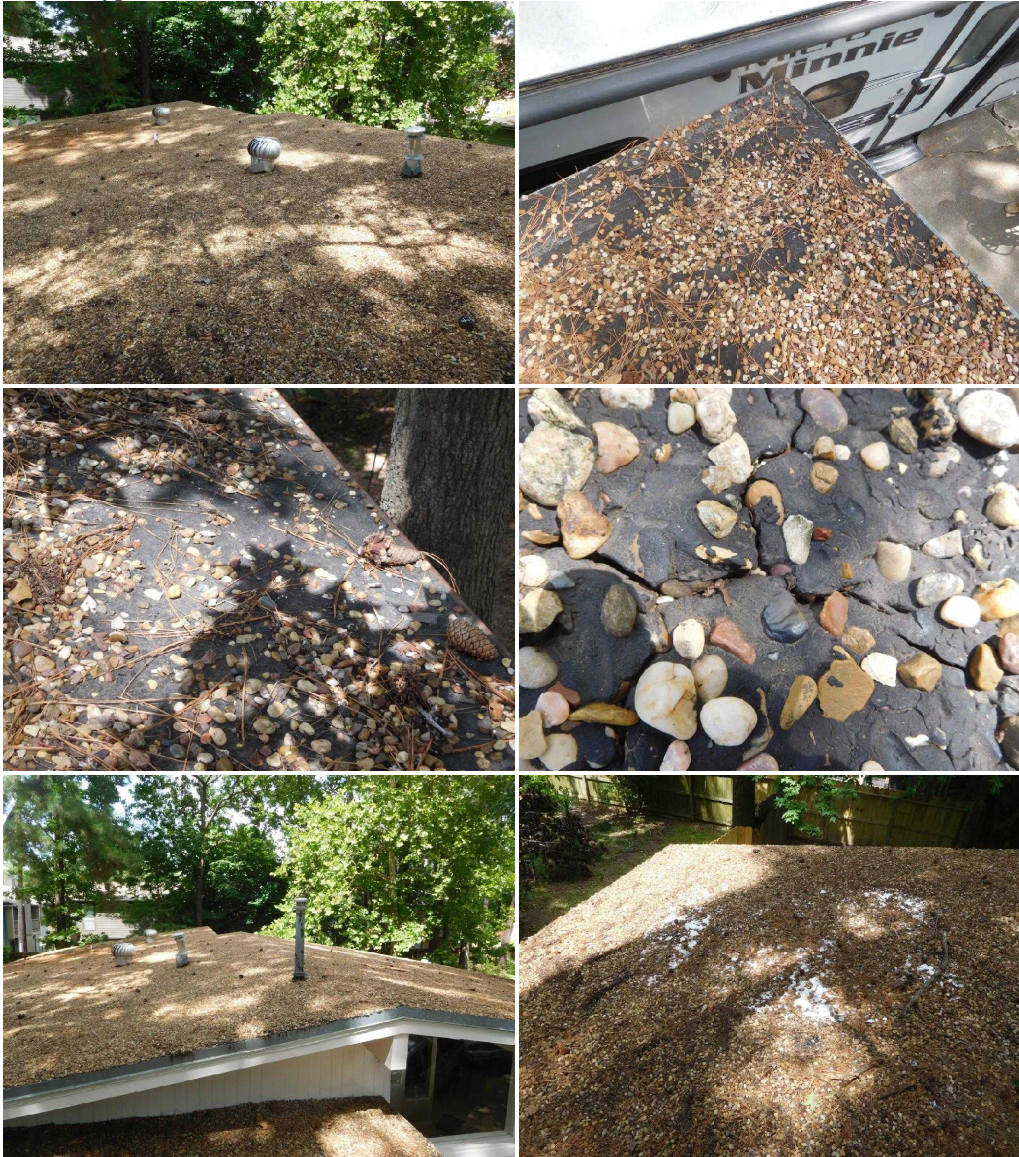
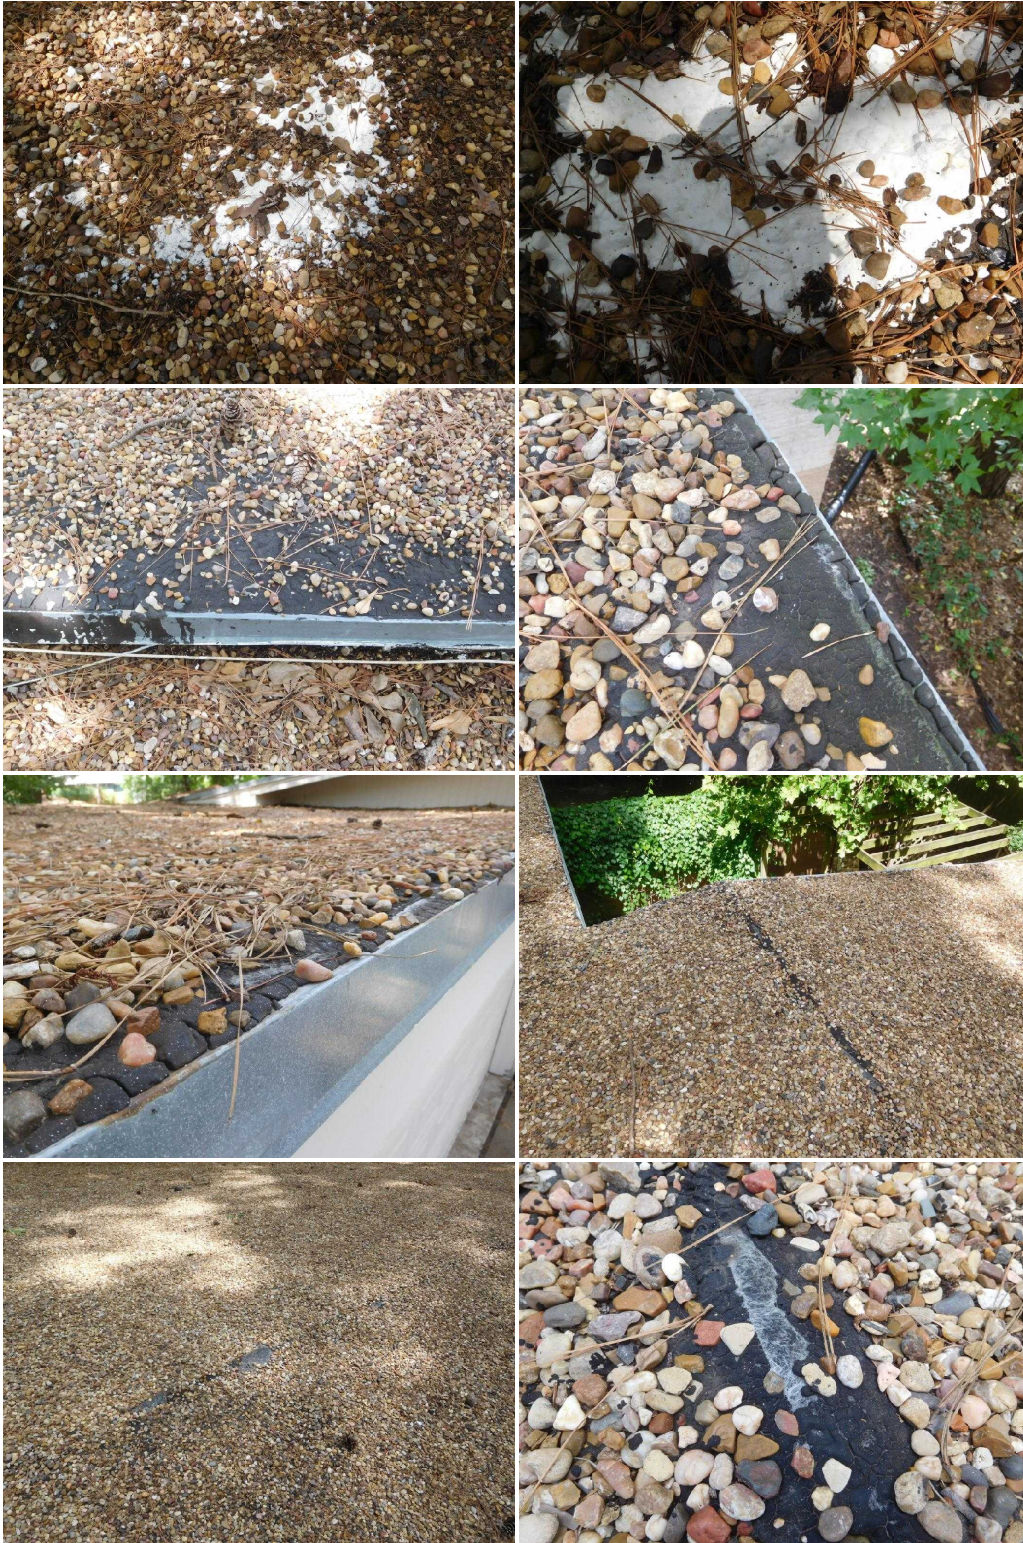
C. Roof Covering Materials (continued)

C. Roof Covering Materials Built-up Tar and Gravel. Many areas of the roof have asphalt coating that is exposed and is oxidized, shrinking back, and cracked (see photos). Many areas have thinly applied/missing gravel.

A section near the northwest corner appears to have been resealed with some type of white colored coating (see photos).

A qualified roofing contractor is recommended to evaluate the roof and estimate for repairs or replacement.

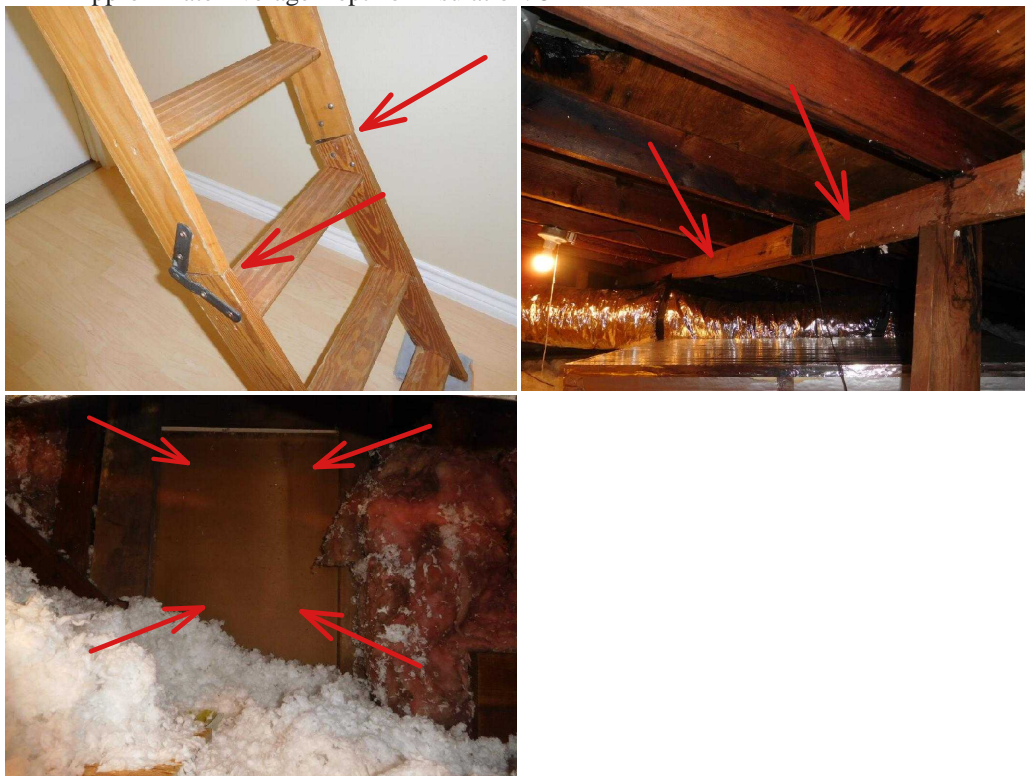
D. Roof Structures and Attics 2x6 Rafter. It was noted that the lower section of the attic access ladder was cut at the incorrect length and the ladder hyper-extends slightly and is less stable as a result (see photo).

A few sections of the vertical wall insulation adjacent to the vaulted ceiling in the entryway and living room have come loose and have fallen away from the wall in the attic (see photo). Replace missing insulation where needed. Viewed From: Within the attic space.

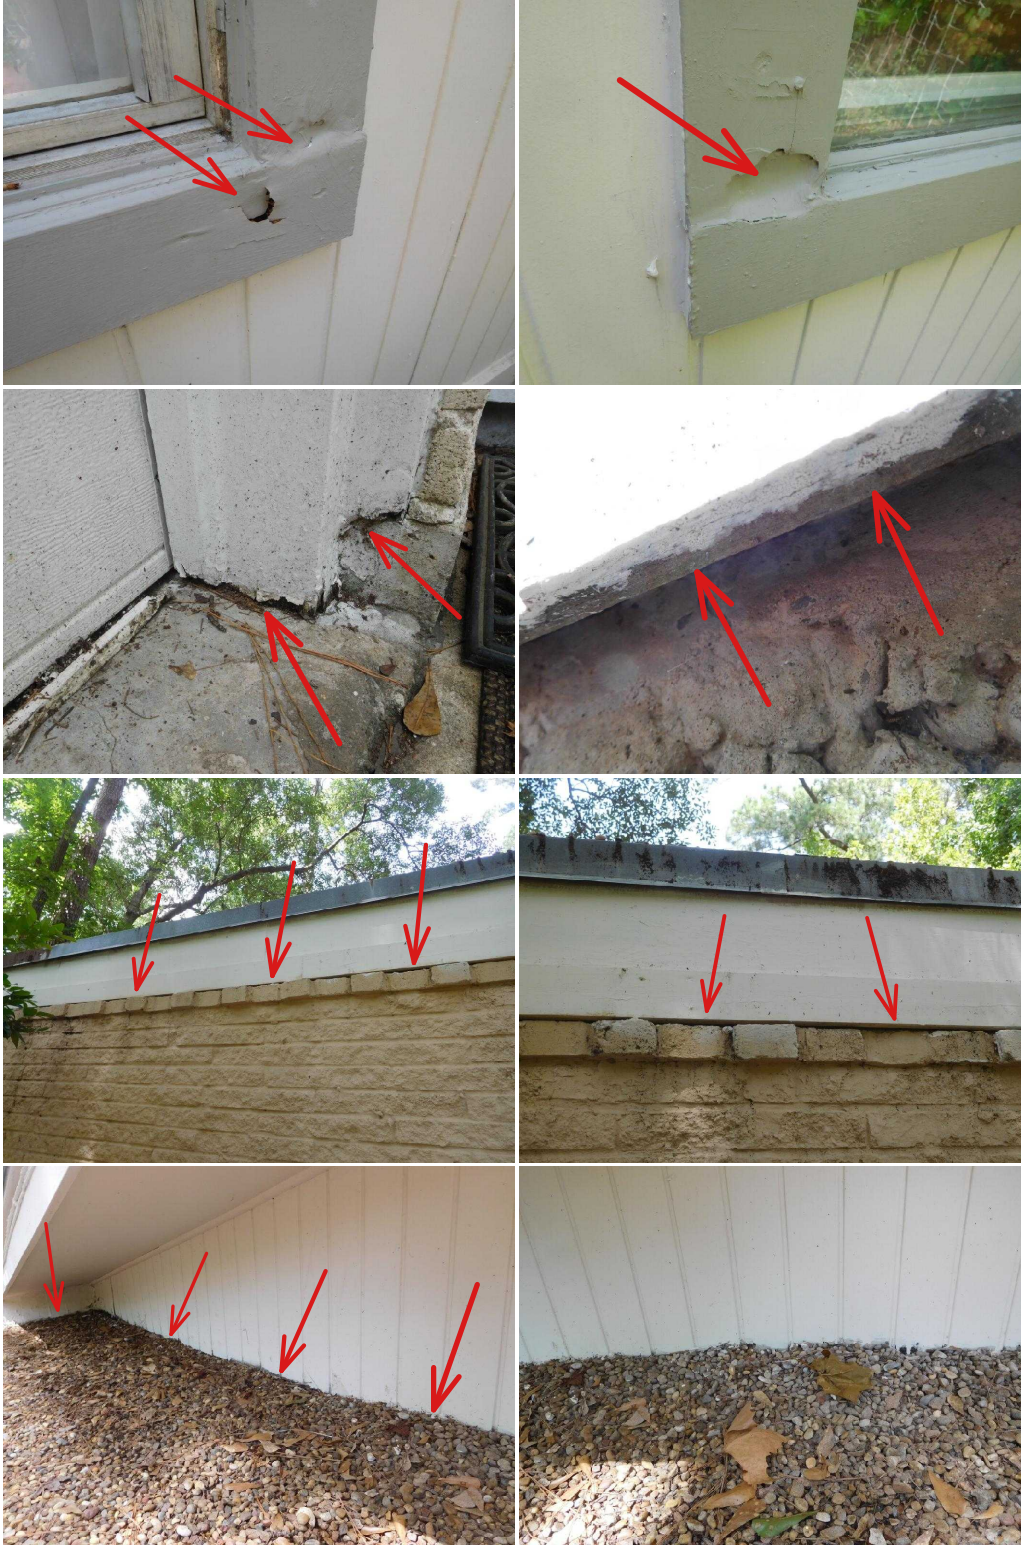
E. Walls (Interior and Exterior) (continued)

However, deterioration due to moisture penetration was noted at a few sections of the wooden trim throughout the exterior, such as at the window trim at the back of the house and garage door frame (see photos). Repair or replace exterior siding and trim as needed.

It was noted that the exterior siding on the rake walls above the garage has been installed directly in contact with adjacent roof surfaces (see photos). A 1" - 1 1/2" space should be left between the bottom edge of the siding and the roof surface to allow for drying and to keep moisture away from the bottom edges of the siding.

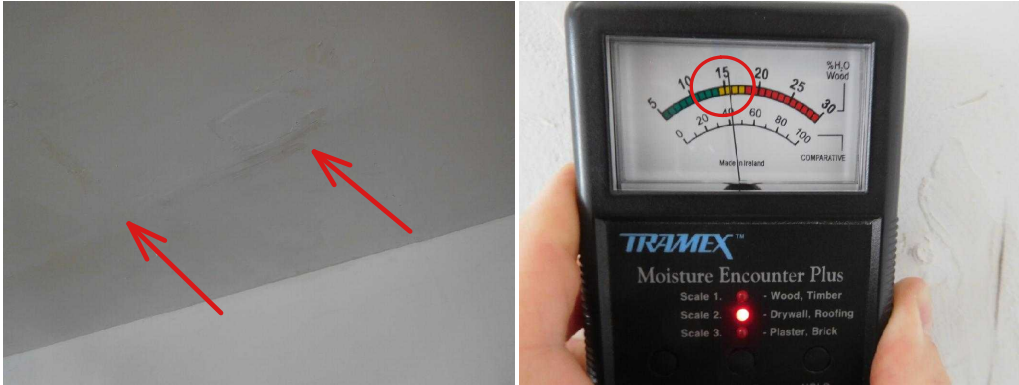
However, stains, patched/repaired sections and elevated moisture levels were noted at the garage ceiling (see photos). Once the roof covering has been serviced or replaced replace wet and damaged materials where needed. Moisture readings were made using a non-destructive moisture meter.

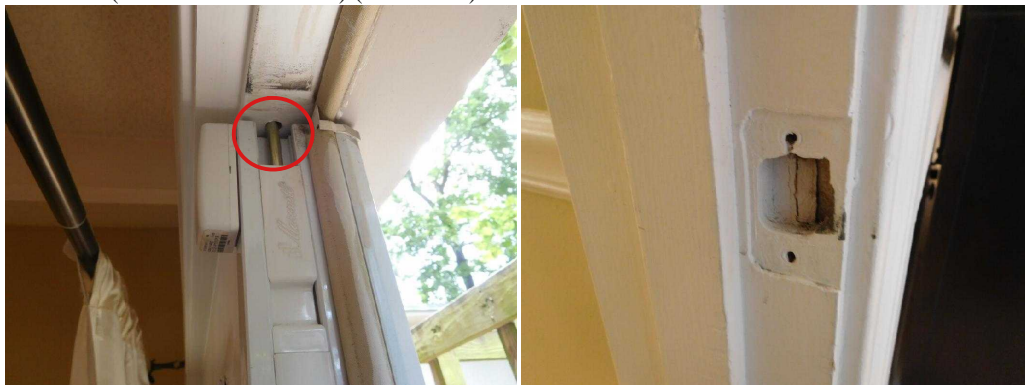
G. Doors (Interior and Exterior) (continued)

G. Doors (Interior and Exterior) It was noted that the door between the attached garage and the living space is not a fire rated door. I recommend properly installing a solid core or metal clad fire rated door and weather stripping at this location as per code and safety. Also, there are no self-closing hinges on the garage walk through door. These hinges are currently required as per code and safety.

There is no thumb latch on the deadbolt lock at the back exterior door. Current standards require keyless operation from the interior side of exterior doors for the purpose of emergency egress.

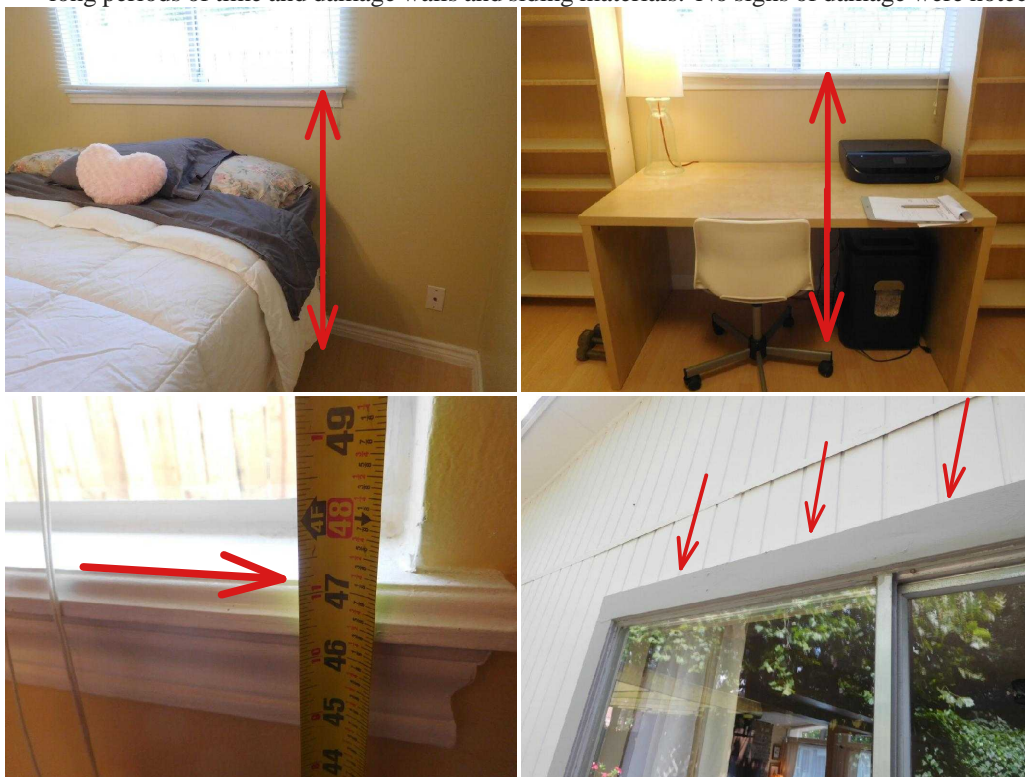
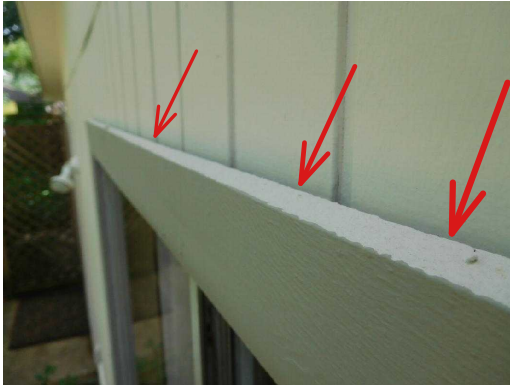
H. Windows (continued)

It was noted that the windows in the front two bedrooms are too high by current standards. Windowsill height in a bedroom should not exceed 44" so that the window may be used as an emergency egress. These sills are approximately 47" above the floor (see photos).

However, there is no drip cap flashing installed at the tops of the windows or back door (see photos). Properly installed drip cap flashing will prevent windows from leaking once the caulk has failed. Moisture entering at the tops of windows can go unnoticed for long periods of time and damage walls and siding materials. No signs of damage were noted at this time.

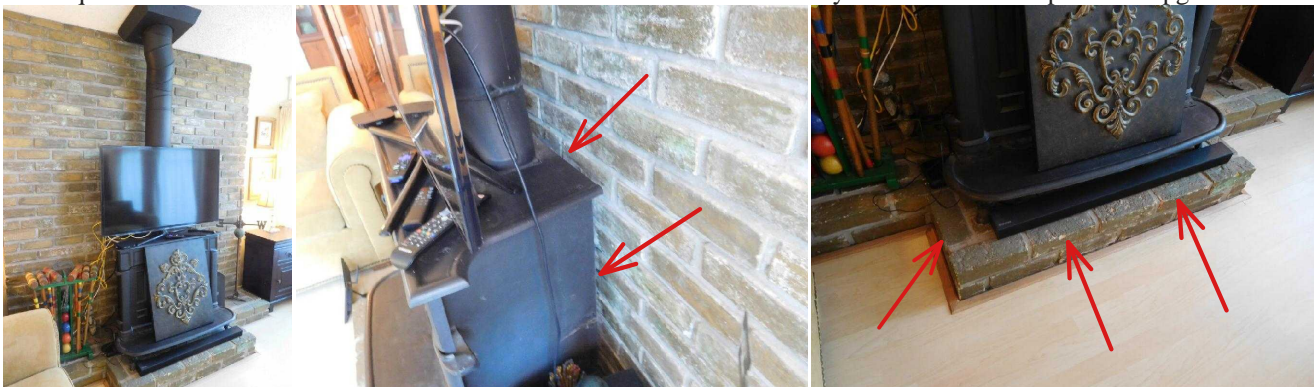
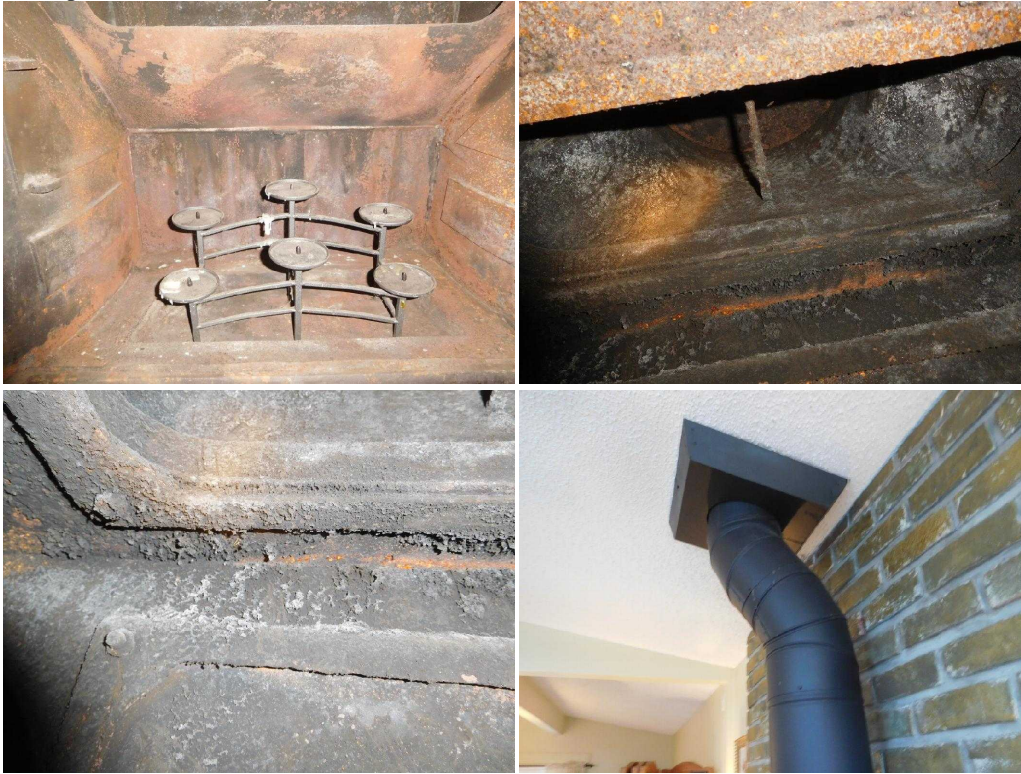
J. Fireplaces and Chimneys (continued)

Proper clearances between the metal chimney pipe and combustibile materials should be maintained, including but not limited to where the vent penetrates the roof deck. This area of the roof was not accessible and the vent penetration was not visually inspected. Ensure that proper clearances were maintained.

A qualified contractor is recommended to evaluate the firebox and chimney and estimate for repairs and upgrades.

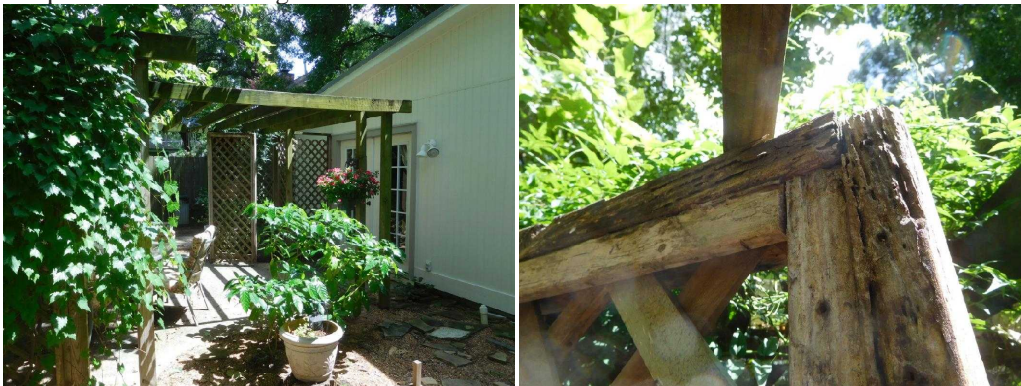
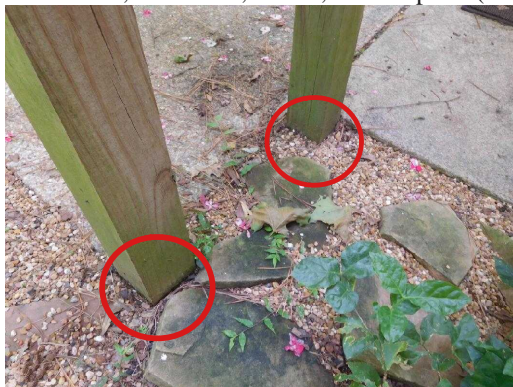
K. Porches, Balconies, Decks, and Carports (continued)

Grain splitting and deterioration were noted throughout (see photo). Repair/replace sections and periodically resecure components as needed.

Wood-to-ground contact was noted at sections along the perimeter of the deck (see photo). This can contribute to moisture penetration and damage and is also conducive to termite infestation.

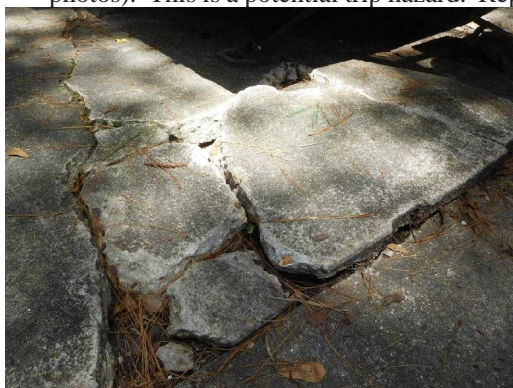
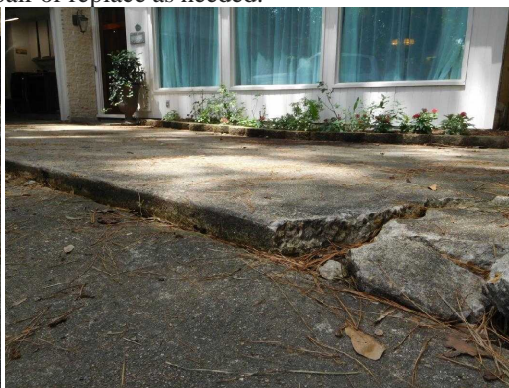
L. Other The driveway is cracked and heaving sections have some degree of differential movement causing an uneven surface (see photos). This is a potential trip hazard. Repair or replace as needed.

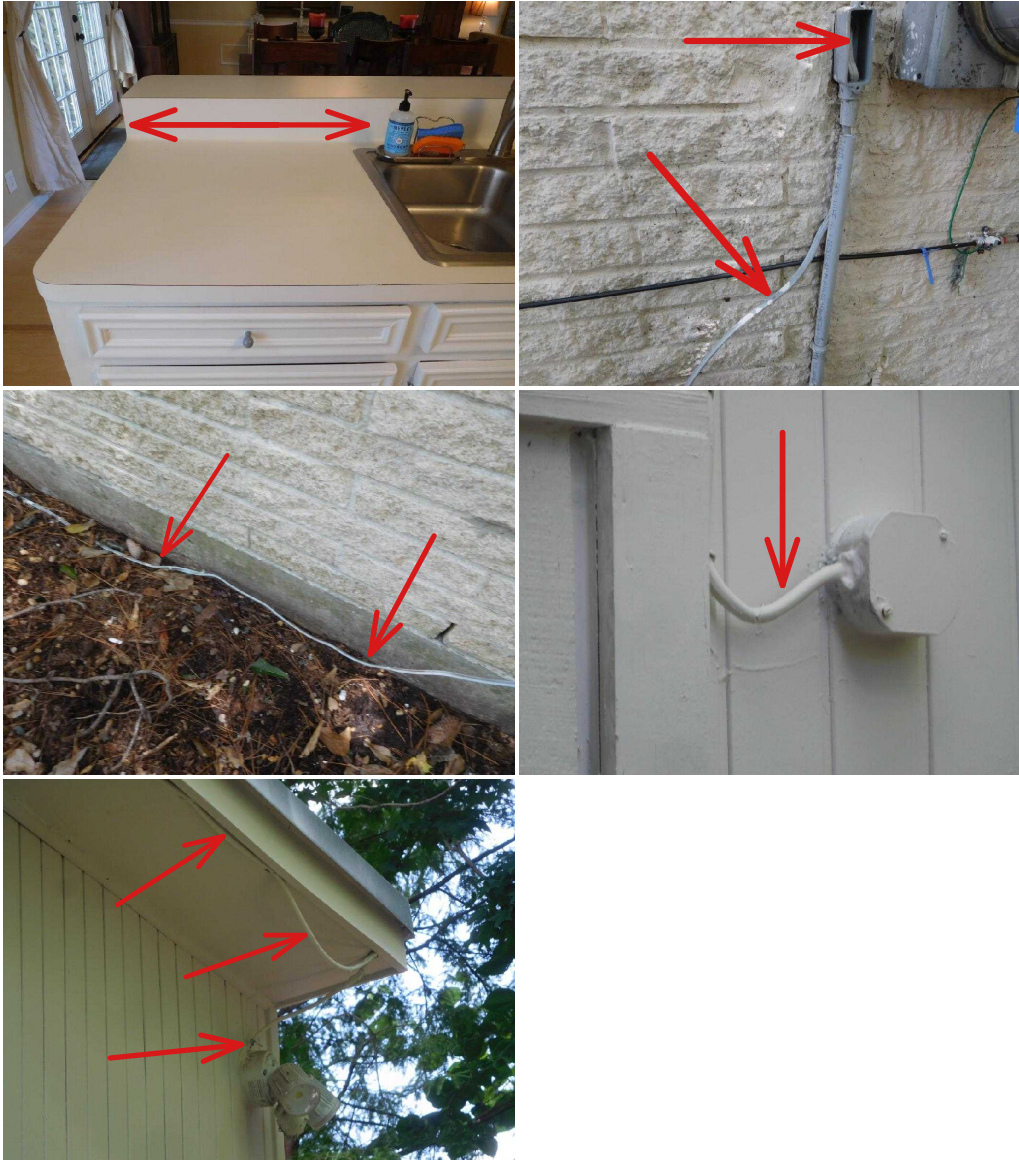
B. Branch Circuits, Connected Devices, and Fixtures (continued)

Exposed exterior electrical wiring was noted running along the north side of the house and resting on the ground and also at the back patio (see photos). All exterior electrical wiring should be properly secured in approved protective conduits as per code and safety.

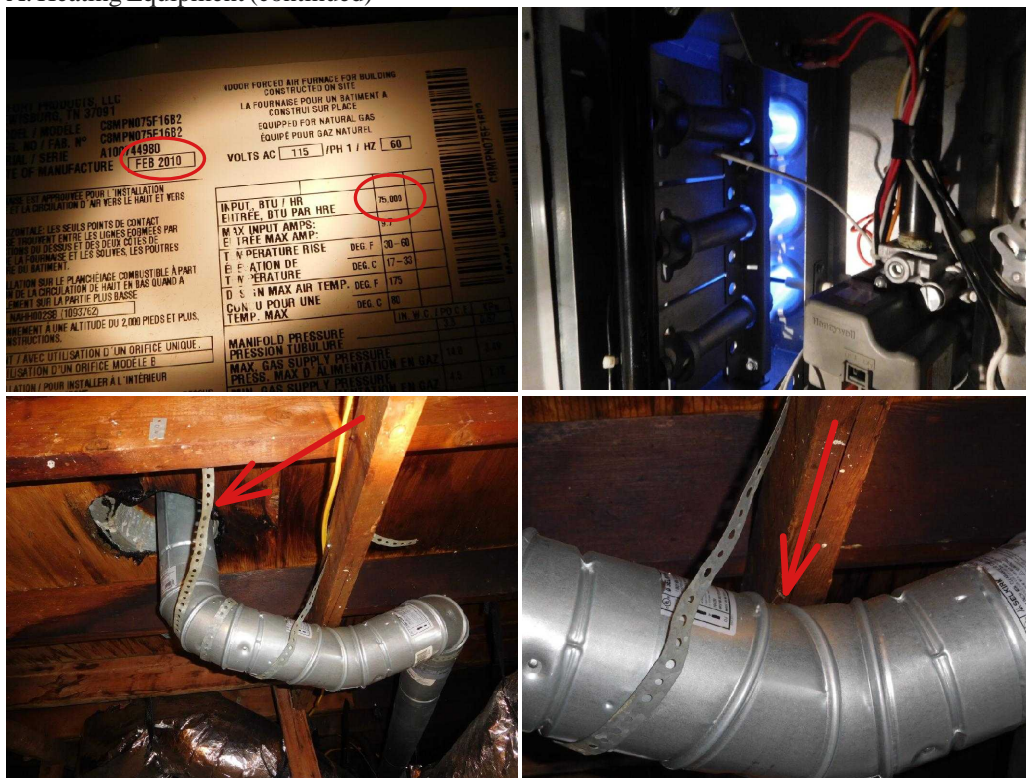
A. Heating Equipment (continued)

However, it was noted that the type 'B' metal exhaust vent is in too close of proximity to one of the wooden purlins and the roof decking at the point where it penetrates to the exterior (see photo). This vent needs to have a minimum of 1 inch clearance to all combustible materials in order to operate safely, as per manufacturer's specifications. Type of System: Natural gas fired forced air furnace. Energy Source: Natural gas.

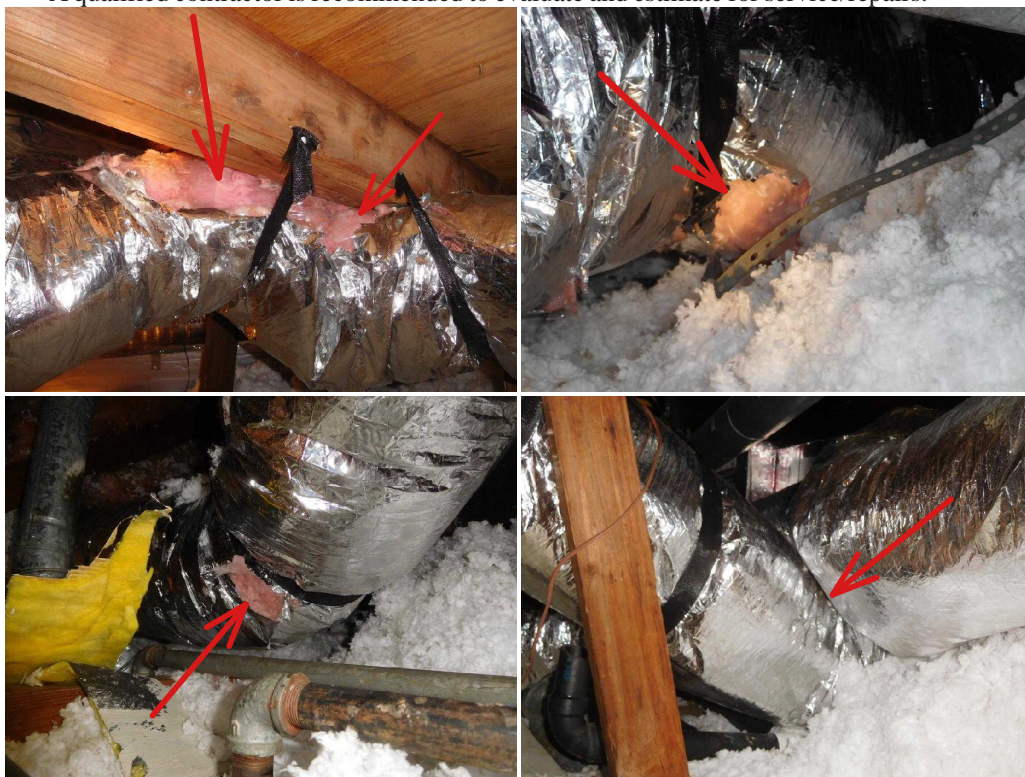
However, a few sections of ductwork have tears in the outer sheathing and some of the insulation layer is exposed (see photo). Seal these sections where needed.

It was noted that some sections of ductwork are in direct contact with each other (see photo). This contact can cause condensation to form on the surfaces of the ductwork. I recommend separating sections from one another or placing insulation material between sections so that there is no direct contact.

A media filter is in place at the air handler in the attic (see photo). Change the filter on a regular basis as per the manufacturer's specifications. Do not install filters in the air return grills in the living space as long as the media filter is in place.

A qualified contractor is recommended to evaluate and estimate for service/repairs.

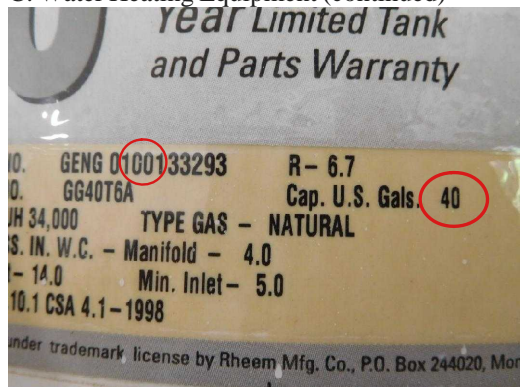
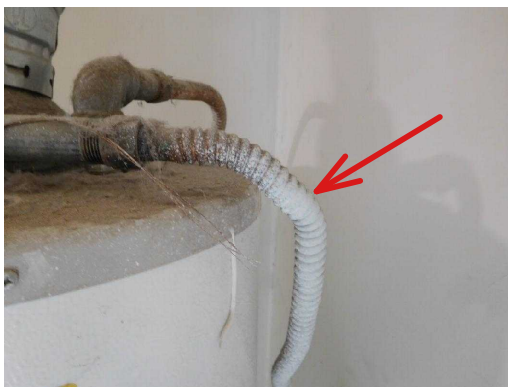
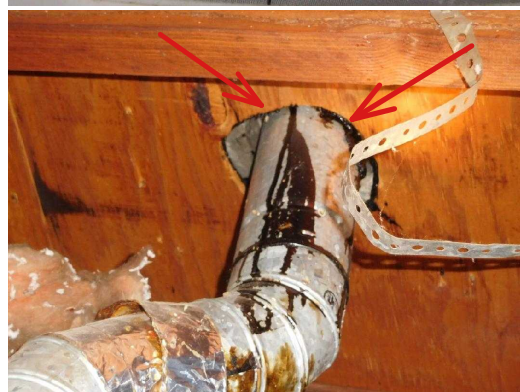
C. Water Heating Equipment (continued)

A section of the temperature pressure relief drain line is comprised of a corrugated flexible tube (see photo). Replace with a smooth wall pipe such as 3/4" CPVC.

It was noted that the metal exhaust vent is in too close of proximity to the wooden roof decking at the point where it penetrates the roof (see photo). This type 'B' metal vent needs to have a minimum of a 1 inch clearance to all combustible materials in order to operate safely. I recommend having a qualified contractor assess this condition and make the necessary correction. Properly install approved metal support strapping to secure the vent between the adjacent rafters.

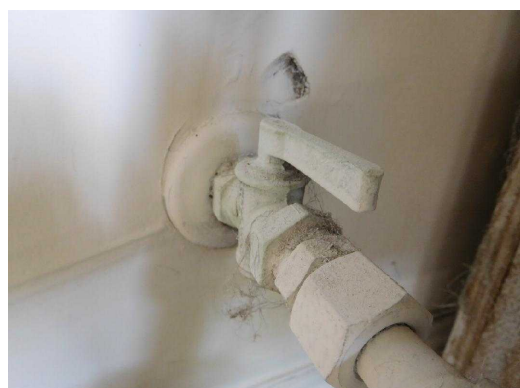
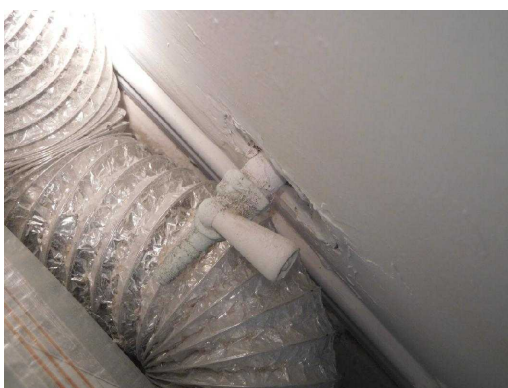
I recommend replacing the old style gas shut off valves with currently approved ball-type valves at the water heater and at the gas supply for the clothes dryer (see photos).

Unless a natural gas fired dryer is going to be installed in the laundry room, the natural gas supply line should be capped using an approved cap (see photo).

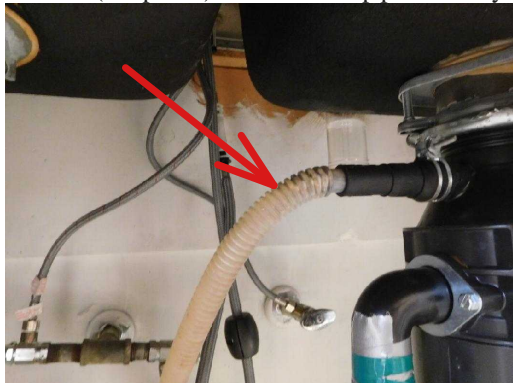
However, I recommend properly looping the drain hose up to the bottom of the counter top and then back down to the disposal/drain line (see photo). This will help prevent any back-flow from occurring during draining.

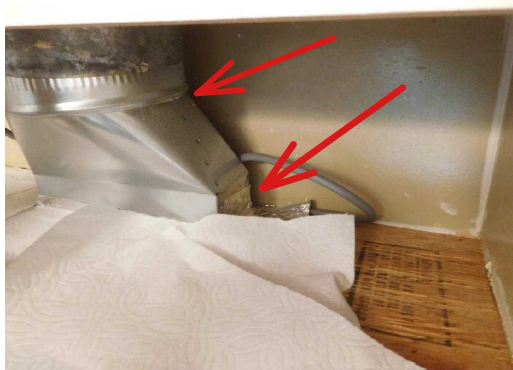
However, gaps were noted in the duct and air is leaking into the cabinet above the unit. Properly seal the duct as needed.

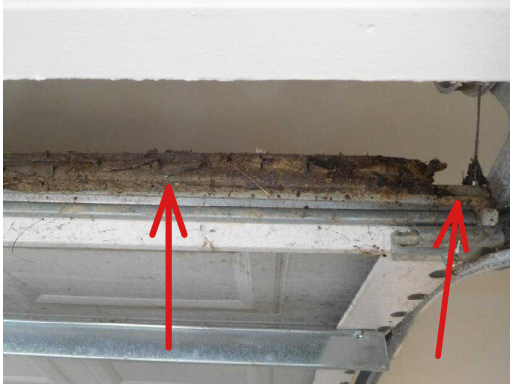
G. Garage Door Operators (continued)

The rubber seal along the bottom edge of the lower panel is deteriorated and partially missing (see photo). Replace.

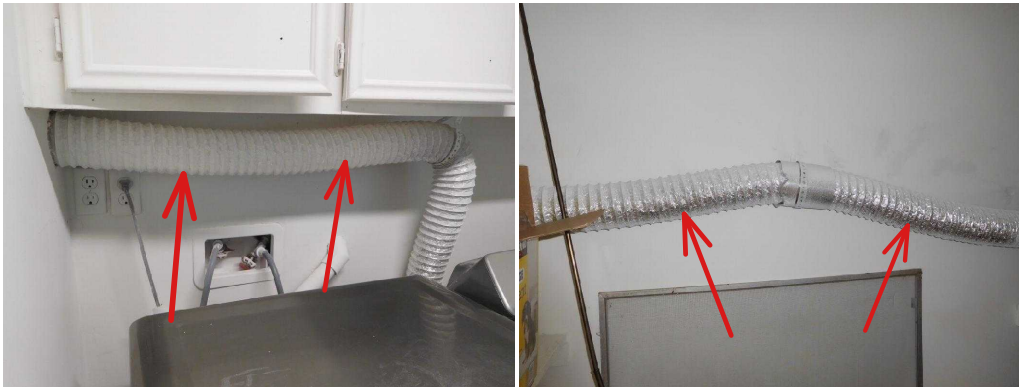
H. Dryer Exhaust Systems The flexible section of the dryer vent behind the unit is comprised of a lightweight flexible mylar foil section of ductwork (see photos). This material is not recommended for dryer vents unless a UL listing label is present. Flex ducts are not permitted in concealed spaces such as a crawlspace and may not be run through walls or other barriers. Flexible vent connections also should not exceed 8' in length. Properly install a rigid metal dryer vent as per code and safety. Replace the flexible section of the vent with a section of flexible metal ductwork approved for use as a dryer vent.
